Asbestos Inspection and Condition Report (Sampling)

Inspection Date: Wed, 18 Sep 2024

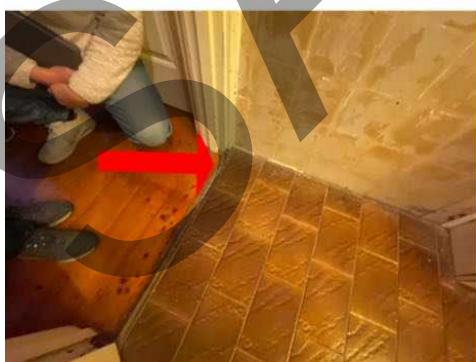
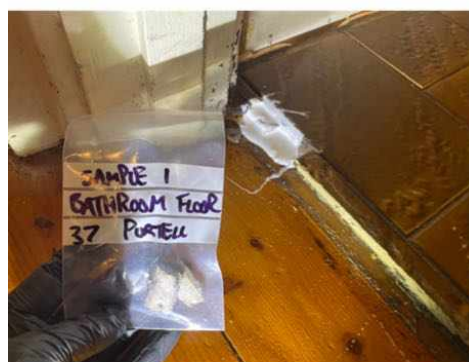
Asbestos, Asbestos Containing Materials and Asbestos Dust 2.01

Building: Main Building
 Location: Ground level Bathroom
 Finding: ACM Suspected Tile Floor Underlay
 Information: The tile floor underlay is suspected to be an asbestos-containing material (ACM). The observable areas of the floor covering and/or underlay appear to be free of damage and deterioration, representing a lesser health and safety risk than if they were in a poor or deteriorating condition.

A sample for lab analysis to confirm the presence of asbestos was taken from this location. The client is advised to assume that the affected area and construction material contains Asbestos until the lab analysis results are available. The area should be avoided, and no works should be undertaken on the area, until lab analysis results are available. Removal by a Licensed Asbestos Removal firm would be advised.

Where the client elects to retain the ACM, the client should regularly monitor the affected area. Such monitoring should be conducted at least annually, but more frequently should damage or evidence of deterioration occur.

No works should be carried out to the flue or associated building elements without further specialist advice.

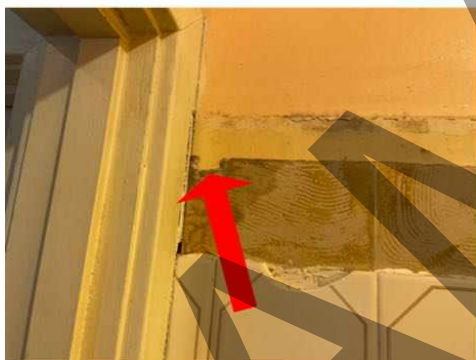
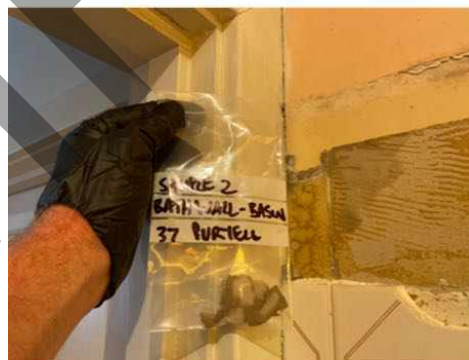
Asbestos, Asbestos Containing Materials and Asbestos Dust 3.01

Building: Main Building
 Location: Ground level Bathroom wall beside basin
 Finding: ACM Suspected behind Ceramic Tiles
 Information: The sheet construction material behind the ceramic tiles in this area is suspected to be an asbestos containing material (ACM). This material is generally found in bathrooms and kitchen environments in this construction context in buildings pre-1985.

The observable areas of sheeting appear to be bonded, undamaged and free of deterioration. Damaged and deteriorated ACM's have a higher probability of releasing airborne asbestos fibres, creating a significant health and safety risk.

A sample for lab analysis to confirm the presence of asbestos was taken from this location. The client is advised to assume the affected area and construction material contains Asbestos until the lab analysis results are available.

The area should be avoided and no works should be undertaken on the area until lab analysis results are available. Should Asbestos be confirmed, the client should arrange for removal by a Licensed Asbestos Removal firm.

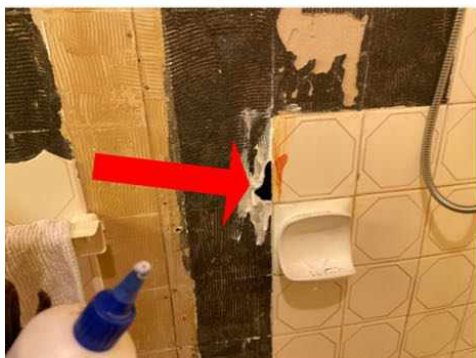
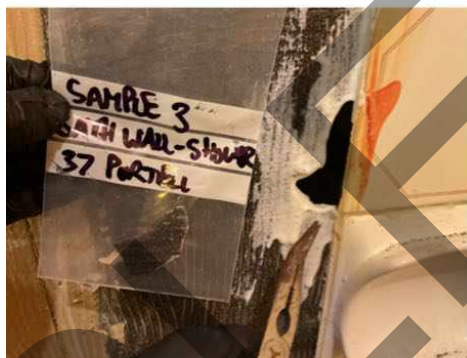
Asbestos, Asbestos Containing Materials and Asbestos Dust 3.02

Building: Main Building
 Location: Ground level Bathroom wall behind shower
 Finding: ACM Suspected behind Ceramic Tiles
 Information: The sheet construction material behind the ceramic tiles in this area is suspected to be an asbestos containing material (ACM). This material is generally found in bathrooms and kitchen environments in this construction context in buildings pre-1985.

The observable areas of sheeting appear to be bonded, undamaged and free of deterioration. Damaged and deteriorated ACM's have a higher probability of releasing airborne asbestos fibres, creating a significant health and safety risk.

A sample for lab analysis to confirm the presence of asbestos was taken from this location. The client is advised to assume the affected area and construction material contains Asbestos until the lab analysis results are available.

The area should be avoided and no works should be undertaken on the area until lab analysis results are available. Should Asbestos be confirmed, the client should arrange for removal by a Licensed Asbestos Removal firm.

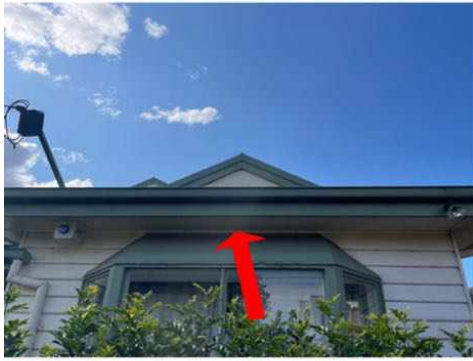
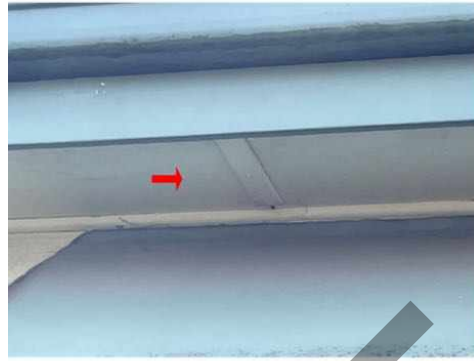
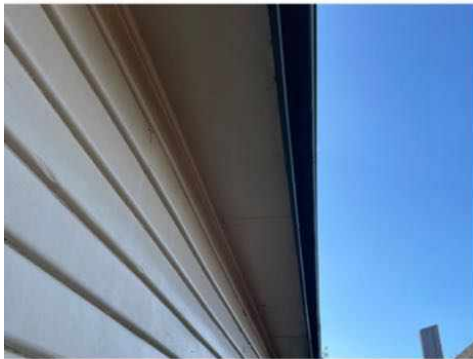
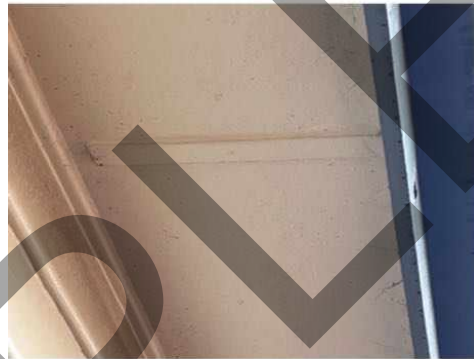
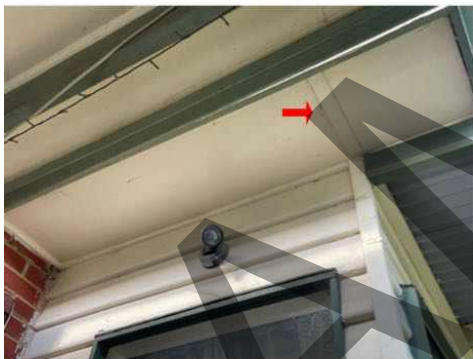
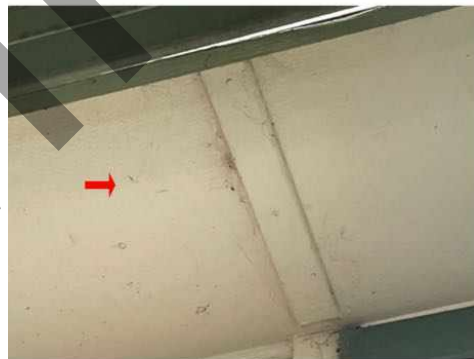
Asbestos, Asbestos Containing Materials and Asbestos Dust 3.03

| Building: | Main Building |
| Location: | All External Areas |
| Finding: | ACM Suspected Eave Sheets |
| Information: | The eave sheets throughout the exterior of the property appear to be an asbestos containing material (ACM). |

The observable areas of eave sheeting appears to have no obvious signs of damage or deterioration, indicating that the asbestos is currently encapsulated and contained. Damaged and deteriorated ACMs are more likely to release asbestos fibres, creating a significant health risk. A sample for lab analysis to confirm the presence of asbestos wasn't taken from this location.

The client is advised to assume that the affected area and construction material contains Asbestos until the lab analysis results are available. The area should be avoided and no works should be undertaken on the area until this time.

Removal by a Licensed Asbestos Removal firm is highly advised. Where the client elects to retain the suspected ACM, the condition of all eave sheeting should be monitored annually. However, more frequent inspections are required should damage or evidence of deterioration occur. Inspection should also cover factors that may lead to the deterioration of the eave sheets, such as minor roof leaks or damage to associated building elements.

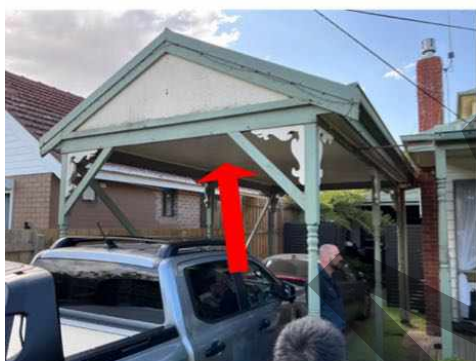
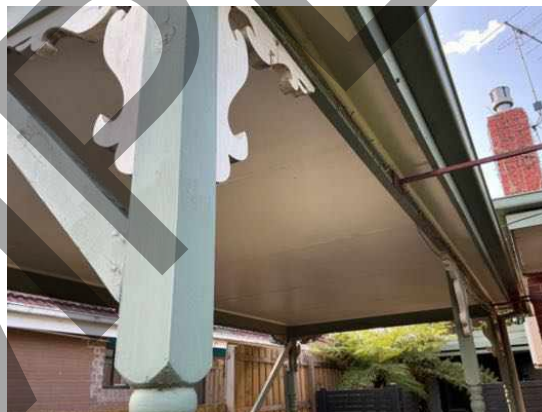
Asbestos, Asbestos Containing Materials and Asbestos Dust 3.04

Building: Main Building

Location: Carport

Finding: ACM Suspected Soffit Sheets

Information: The Soffit to the carport appear to have been constructed with the use of asbestos-containing materials (ACM). At the time of inspection, the observable areas of the ceiling sheets were free of damage and deterioration, representing a lesser health and safety risk than if they were in a poor, damaged or deteriorating condition.

A sample for lab analysis to confirm the presence of asbestos wasn't taken from this location. The client is advised to assume the affected area and construction material contains Asbestos until the lab analysis results are available. Consequently, the area

should be avoided and no works should be undertaken on the area until lab analysis results are available.

Removal by a Licensed Asbestos Removal firm would be strongly advised. Where the client elects to retain the ACM, the client should regularly monitor the condition of the ceiling sheets to identify any further damage or deterioration. Such monitoring should be conducted at least annually, but more frequently should damage or evidence of deterioration occur.

Inspection should also cover factors that may lead to the deterioration of the ceilings, such as minor roof leaks or structural movement. Additional remedial work is a potential short- to medium-term solution to reduce the risk presented by the ACM. Where possible, the encapsulation of the asbestos materials using an appropriate sealant, again by a specialist contractor, can be considered.

No works should be carried out to the ACM or associated building elements without further specialist advice.

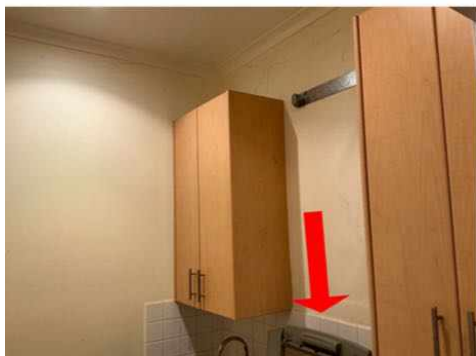
Asbestos, Asbestos Containing Materials and Asbestos Dust 3.05

| Building: | Main Building |
| Location: | Laundry |
| Finding: | ACM Suspected behind Ceramic Tiles |
| Information: | The sheet construction material behind the ceramic tiles in this area is suspected to be an asbestos containing material (ACM). This material is generally found in bathrooms and kitchen environments in this construction context in buildings pre-1985. |

The observable areas of sheeting appear to be bonded, undamaged and free of deterioration. Damaged and deteriorated ACM's have a higher probability of releasing airborne asbestos fibres, creating a significant health and safety risk.

A sample for lab analysis to confirm the presence of asbestos wasn't taken from this location. The client is advised to assume the affected area and construction material contains Asbestos until the lab analysis results are available.

The area should be avoided and no works should be undertaken on the area until lab analysis results are available. Should Asbestos be confirmed, the client should arrange for removal by a Licensed Asbestos Removal firm.

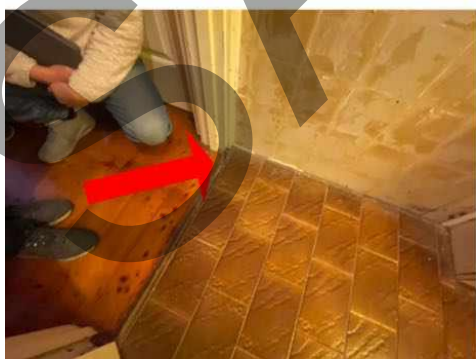
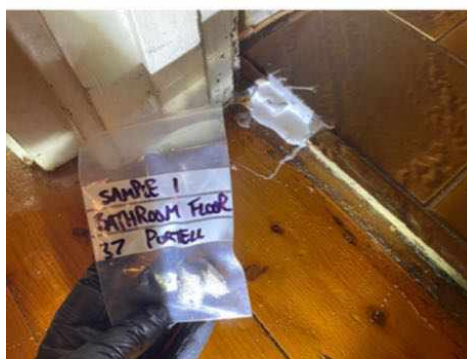
Asbestos, Asbestos Containing Materials and Asbestos Dust 4.01

Building: Main Building
 Location: Ground level Bathroom
 Finding: Asbestos - ACM Confirmed - Tile floor underlay
 Information: Samples of suspected Asbestos Containing Material (ACM) were removed from the building for analysis by a NATA accredited laboratory. The sample results confirmed that the material/s tested do contain Asbestos. The results indicated that the type of Asbestos is White Chrysotile

The sheet below the tiles on the bathroom floor was confirmed to contain ACM and in its current state should be removed by a licensed asbestos removalist.

Consequently, the client is advised to consider relevant risk reduction strategies, including removal by a licensed Asbestos Removal firm.

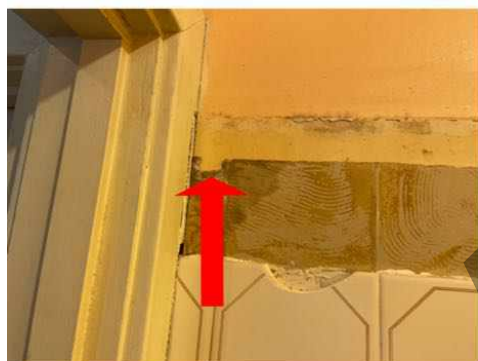
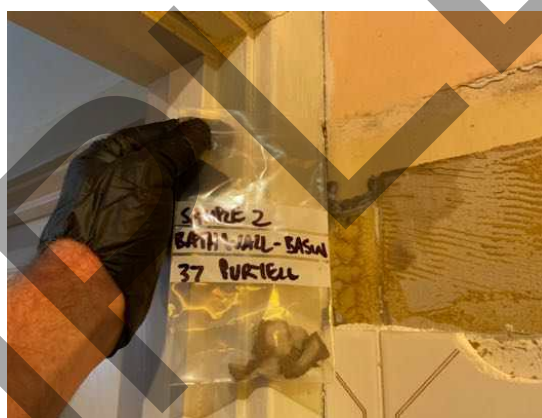
Building: Main Building
 Location: Ground level Bathroom wall beside basin
 Finding: Asbestos - Negative Lab Result - Wall beside basin
 Information: Samples of suspected Asbestos Containing Material (ACM) were removed from the building for analysis by a NATA accredited laboratory.

The samples analysed were free of Asbestos fibres.

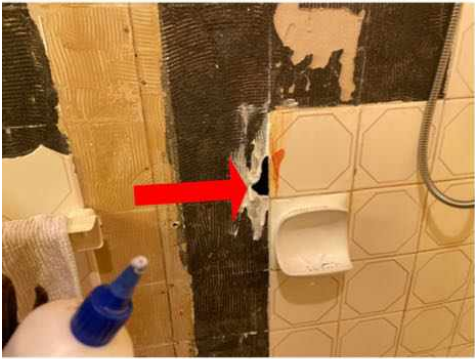
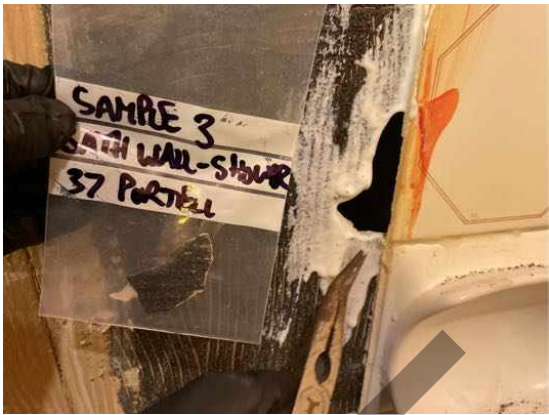
Building: Main Building
 Location: Ground level Bathroom wall beside basin
 Finding: Asbestos - Negative Lab Result - Wall behind shower
 Information: Samples of suspected Asbestos Containing Material (ACM) were removed from the building for analysis by a NATA accredited laboratory.

The samples analysed were free of Asbestos fibres.
