Building Inspection Report

Inspection Date: Sat, 10 Jul 2021

Property Address: SAMPLE REPORT - PRE PURCHASE

Company Name: Jim's Building Inspections

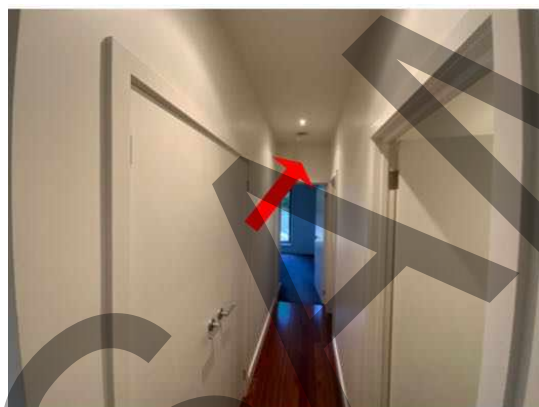
Defects 1.01

Please note that this defect is highlighted as a caution only. We suspect, based on our experience in the building industry, that the absence of smoke detectors, or their poor condition, should be addressed as a matter of urgency to improve occupant safety.

Further Inspection and/or advisory services is necessary to provide advice on the sufficiency, type and location of smoke detectors, and to test the functionality of all devices.

Always ensure sufficient working and suitable smoke detectors are installed prior to occupying any building.

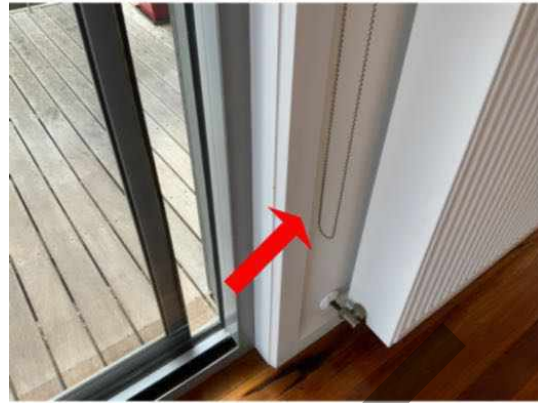
Defects 1.02

Building:	Main Building
Location:	All Internal Areas
Finding:	Curtain & Blind - Safety Cord
Information:	Looped curtain and blind cords pose a significant strangulation hazard for children as they can place the loop over their head and/or get tangled in the loose cords. The mandatory standard for blinds, curtains and window fittings (in place from 30th December 2010) requires all new window furnishings to come with warning labels and to be installed with tensioning devices. However, as this standard is not retrospective,

Check all the rooms in your house for any blinds or curtains with long cords that are either loose or looped. This includes any cords that are within children's reach at floor level or near furniture they can climb on. Secure any loose or looped cords with cleats or tension devices – these can be purchased from your local curtain and blind retailer or hardware store.

Do not put furniture such as cots, beds, highchairs, playpens, couches, chairs, tables or bookshelves near a window where children can reach the blind or curtain cord. When installing new blinds and curtains, make sure you or the installer secures any loose or looped cords immediately.

It's recommended that this defect be resolved immediately to avoid harm to occupants. Consumer Affairs Victoria can be contacted for further information and have free curtain and blind cord kits that are suitable for roller blinds with looped cords and wooden window frames.

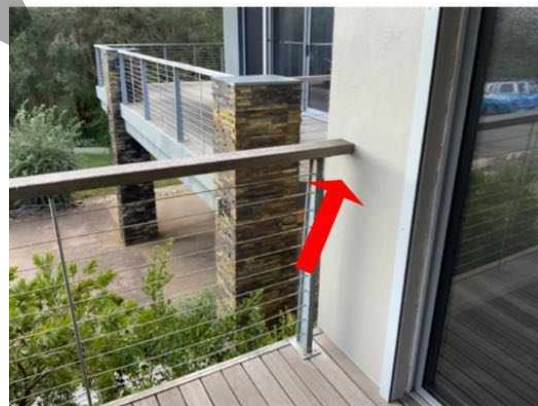
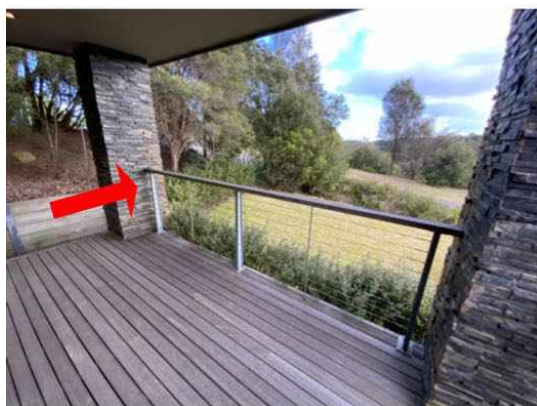
Defects 1.03

Finding: Balustrade Handrail - Loose

Information: Upon inspection of the balcony balustrade outside the master bedroom, it was noted that the handrail is loose and has excessive movement. It is suspected that this defect has developed as a result of a lack of adequate maintenance, but may also have been caused by inappropriate fixings being used in the construction process.

If left unaddressed, it is likely that secondary damage to associated building elements will develop, potentially necessitating remedial works to the wall structure. A balustrade contractor should be appointed to advise on rectification options. It is advised that remedial works be performed as soon as possible to prevent any further damage or unsafe conditions during use of the balcony.

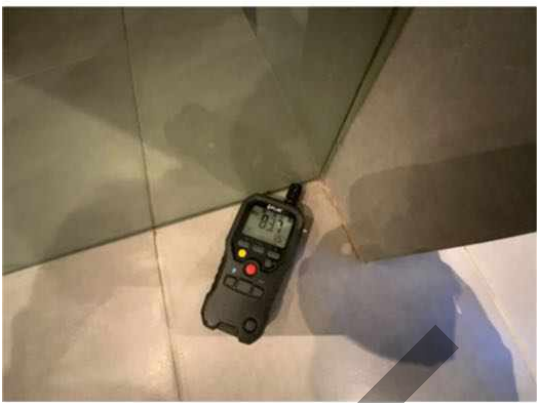
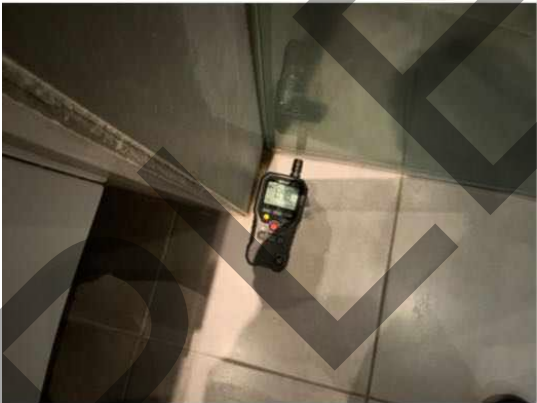
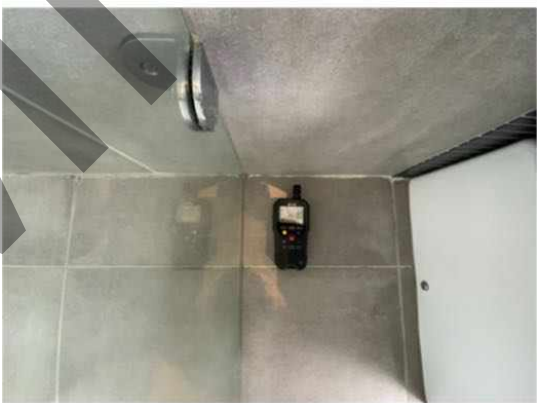
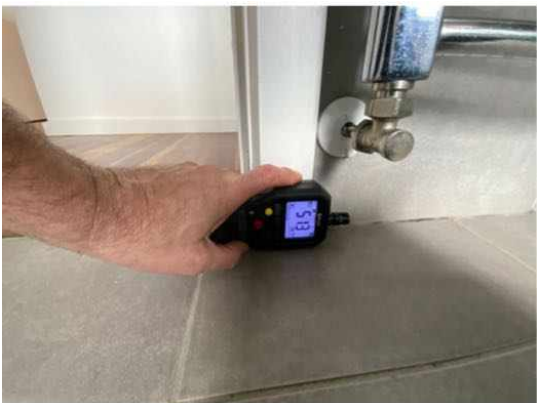
Defects 2.01

Building:	Main Building
Location:	Bathroom - Ensuite
Finding:	Shower Alcoves - Suspected Leak
Information:	It is suspected that leaking from the master bedroom ensuite and bathroom shower alcoves has occurred at the time of inspection. Moisture readings taken outside the shower alcove areas indicated elevated dampness. Distorted paint on the bathroom door jamb also indicates that moisture is trapped below the tiled flooring.

This defect is quite common, and is suspected to have been caused by defective waterproofing within the shower alcove areas. It is suspected that water stops have not been installed around the shower alcove perimeter.

Moisture permeating through the grouting and sealants in the shower alcove may also be a contributing factor. Unmanaged dampness is likely to facilitate the formation and development of mould and fungi growth, decaying associated building materials and compromising their structural integrity.

Consultation with a registered building practitioner is advised immediately to identify the cause of dampness and to perform remedial works as required.

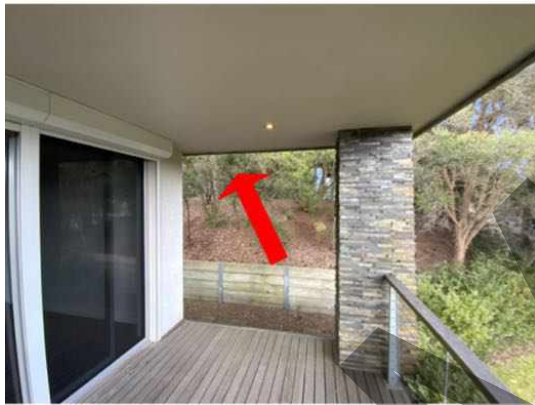
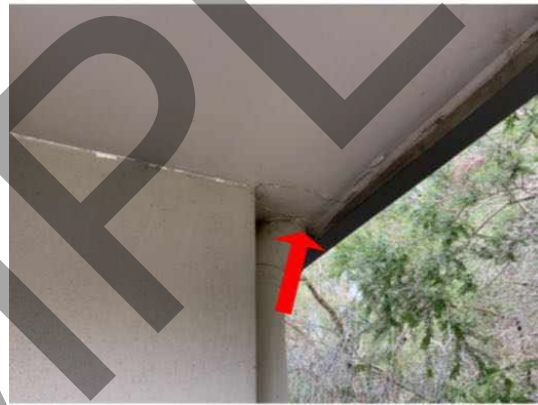
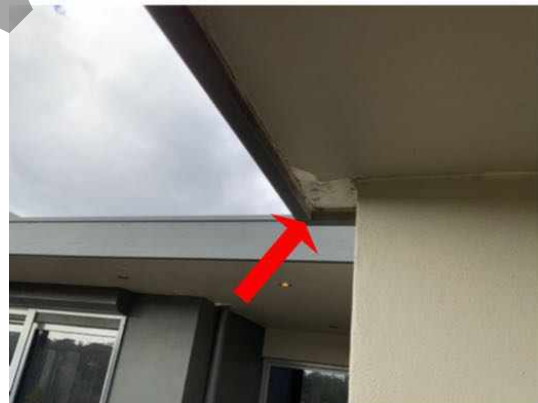
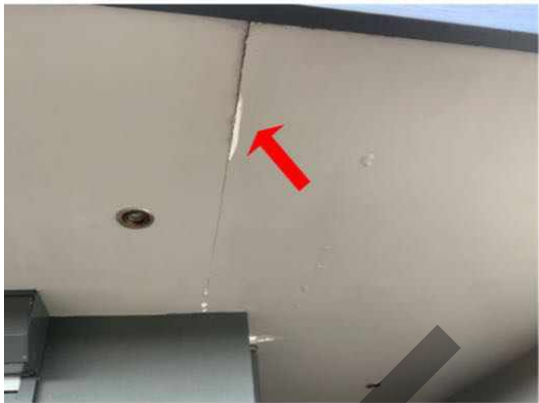
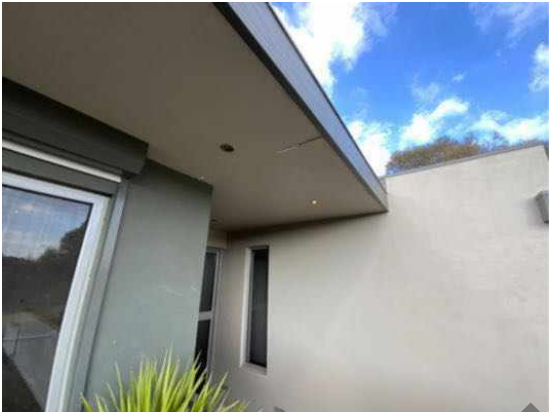
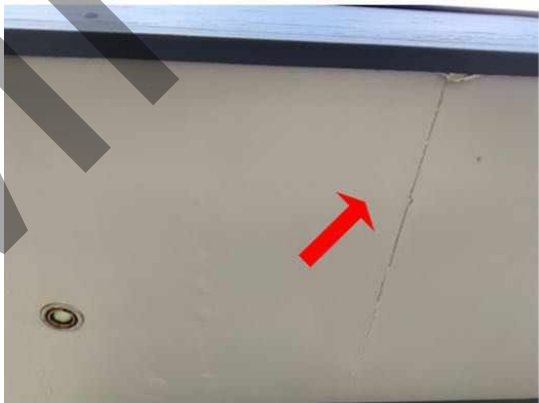
Defects 2.02

Building: Main Building
Location: All Areas
Finding: Eave Sheeting - Water Stained & Cracked
Information: Water staining and cracking to eave linings at the front and side elevations of the property was evident at the time of inspection. Water staining indicates that surfaces have been exposed to excessive moisture over time. Cracking indicates that there has been expansion and contraction of the eave structure.

Water staining can be indicative of more serious defects, which may be currently concealed by the eave linings or external roof tiles. Where water staining is active, a licensed plumber must be consulted to identify the cause of the staining and to provide advice on any reparation works that may be required.

Replacement of any damaged structures is advised and should be completed by a registered building practitioner.

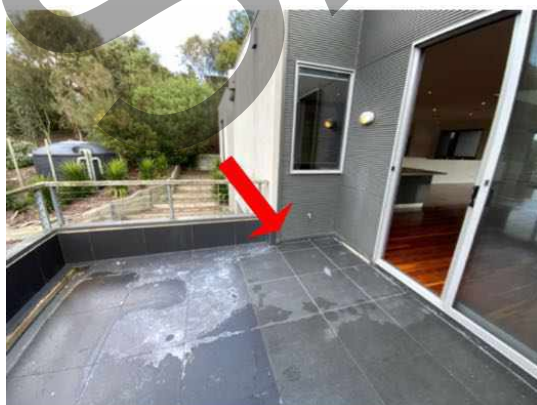
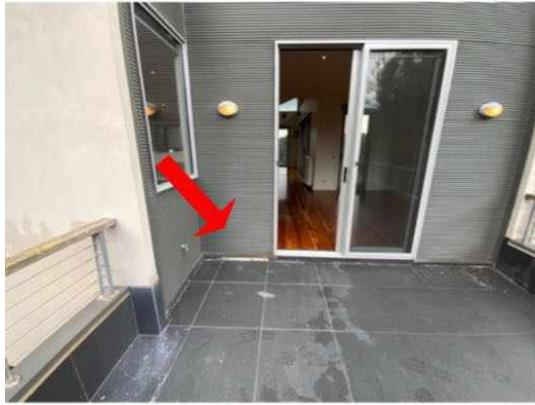
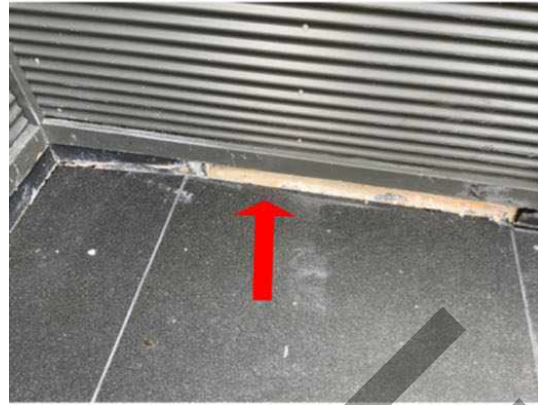
Defects 2.04

Building: Main Building
Location: Rear Balcony
Finding: Cracked Balcony Tiles
Information: Cracking to the balcony floor tiles was evident at the time of inspection. It is suspected that this cracking has occurred as a result of minor settlement or shrinkage of the balcony substructure. Substandard installation of the balcony waterproofing system may also be a contributing factor. Cracked tiles on a balcony detract from the overall appearance of the affected areas and may lead to secondary defects occurring.

A registered building practitioner should be immediately appointed to further assess and perform rectification works. The client should be aware that replacement of the balcony waterproofing system and tiling may be required as there was evidence of water damage to the bedroom ceiling below the balcony.

Where cracks become more numerous, immediately contact a structural engineer for a further investigation.

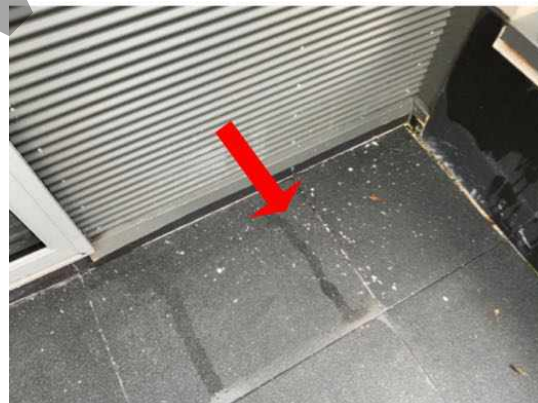
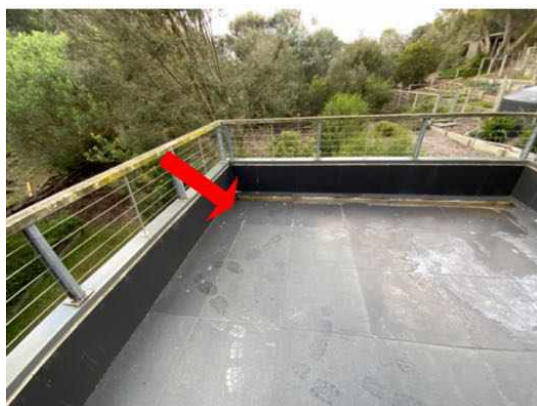
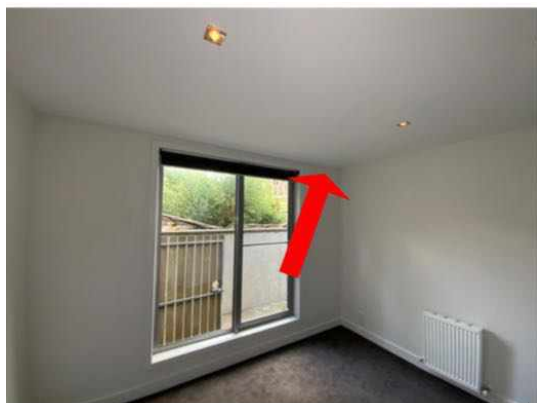
Defects 2.05

Building:	Main Building
Location:	Rear Balcony - Bedroom 4
Finding:	Evidence of Recent Repairs
Information:	There was evidence of recent repairs to the rear balcony area and to the bedroom 4 ceiling located below the balcony.

Where evidence of recent balcony repairs or plaster work is present, it is recommended that the vendor provide further information about the purpose of repairs. It is not uncommon for ceilings to be repaired below upper levels that may contain areas such as balconies if leaking has occurred.

If the vendor is not able to provide further information, a further invasive inspection of the ceiling void is recommended by a registered building practitioner.

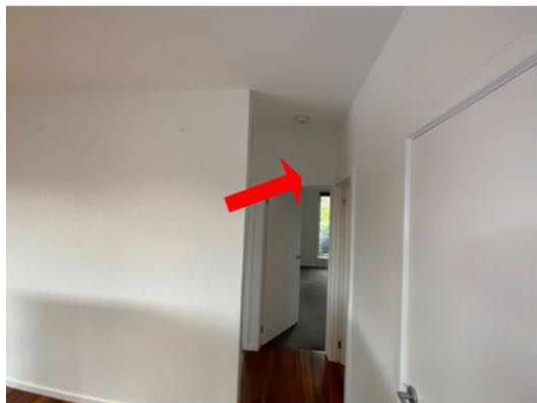
Defects 3.01

Building:	Main Building
Location:	Hall
Finding:	Cracking to internal Walls
Information:	Although cracks to sections of the internal walls are quite noticeable, they are often only considered to be an appearance defect, and usually do not indicate any structural damage. Generally, the cause of the cracks is due to general building movement, indicative of a separation between building materials and finishes (e.g. paint, plaster, etc.) along joints.

Cracking of this nature can generally be repaired with minor sanding, filling and/or repainting. Such works should be performed by a qualified painter or a plastering contractor.

Monitoring of all cracking should be conducted frequently. Always contact a building consultant should cracks widen, lengthen, or become more numerous.

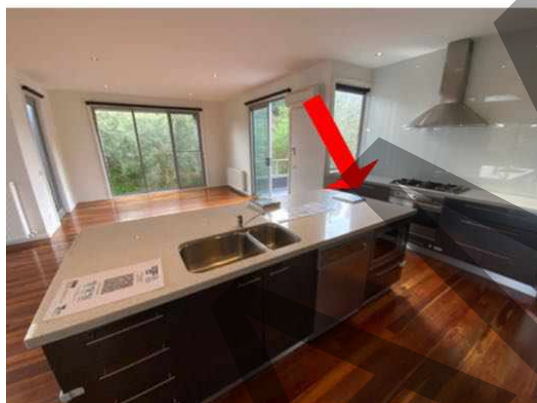
Defects 3.02

Building: Main Building
 Location: Kitchen
 Finding: Bench Top - Cracked
 Information: Cracking to the edge of the kitchen benchtop was observed at the time of inspection.

It is recommended that a benchtop specialist be engaged to assess the crack and to carry out further repairs to avoid further deterioration of the bench top.

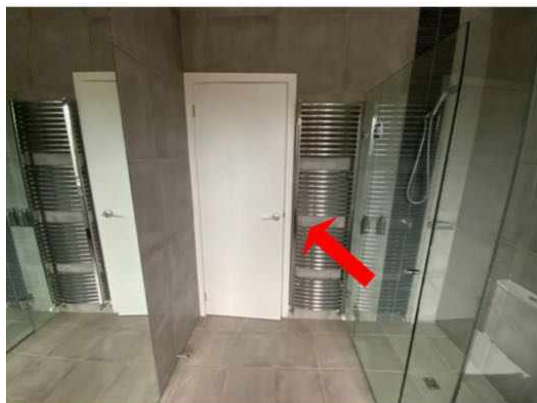
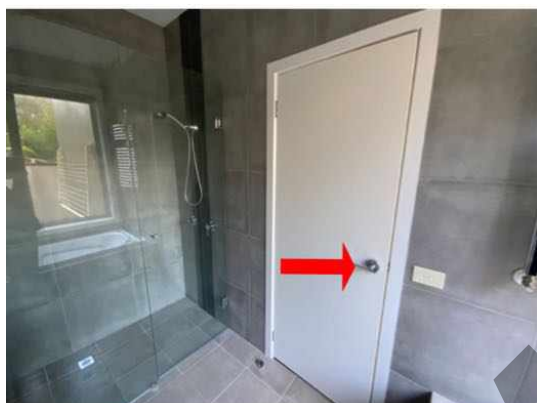
Defects 3.03

Building: Main Building
 Location: All Internal Areas
 Finding: Door - Striker Plate Misaligned
 Information: The striker plate to several internal doors appear to have become misaligned and has consequently resulted in the door's operation being compromised.

This is a common defect and is expected in a property of this age, whether being due to substandard installation or general deterioration of the door hardware.

Readjustment of the striker plate is recommended at client discretion.

Works such as these can be completed by a general handyman or qualified carpenter.

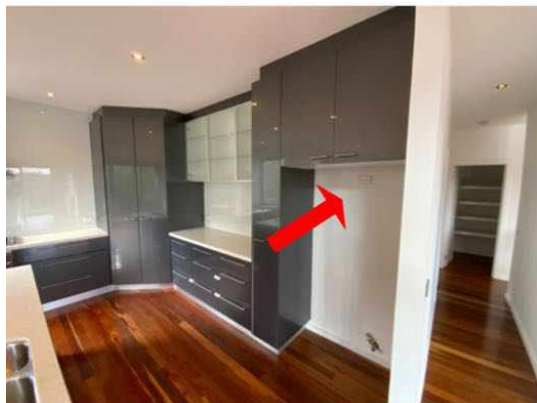
Defects 3.04

Building:	Main Building
Location:	Kitchen
Finding:	Power Point - Cover Plate Missing
Information:	The power point cover plate was found to be missing in this area at the time of inspection. Although some building elements may seem irrelevant or unnecessary, all building elements play a key role in the operation and function of the overall structure and its performance.

Replacement of any missing building element should be conducted as soon as possible to ensure that no damage or functional issues occur to associated building materials. A licensed electrician should be appointed to install a new power point cover plate as soon as possible.

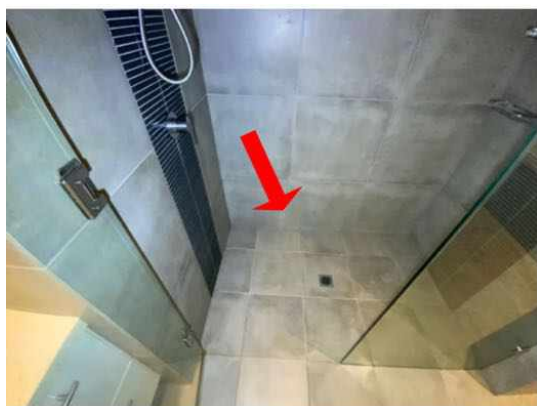
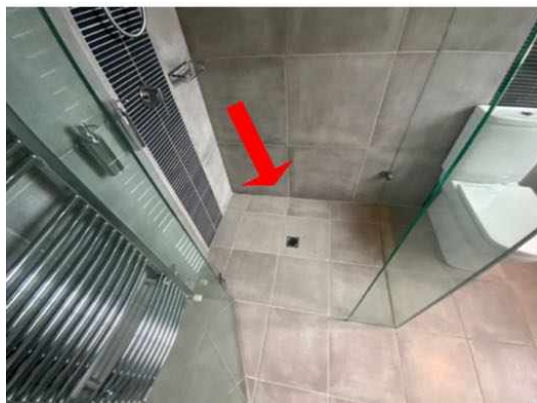
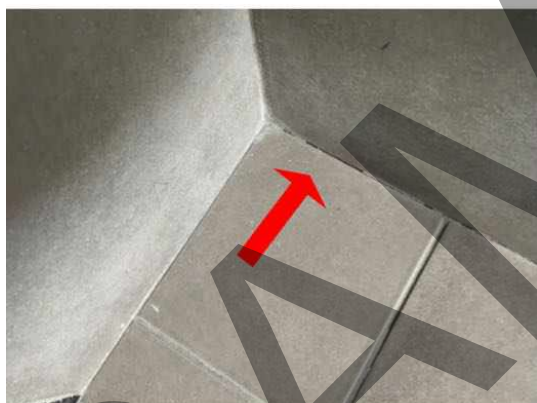
Defects 3.05

Building: Main Building
 Location: Bathroom - Ensuite
 Finding: Shower Alcove - Sealant & Grout Deteriorated
 Information: There appears to be deterioration of the grout and sealants in the shower alcove areas of the master bedroom ensuite and upstairs bathroom. This type of deterioration typically occurs when excess moisture is trapped below the tiles and within the waterproofing system.

This type of deterioration can be an indication of defective waterproofing if located in areas such as shower alcoves or bathroom tiling.

A registered building practitioner should be engaged to further assess the affected shower alcove areas and provide recommendations on required rectification works. This defect should not be left unattended as water escape from the shower alcove and further deterioration of the grouting and tiled areas may occur.

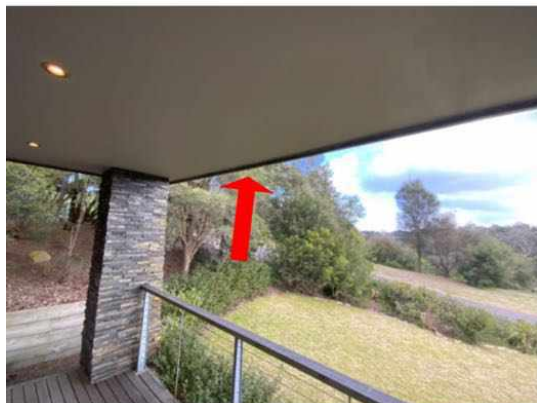
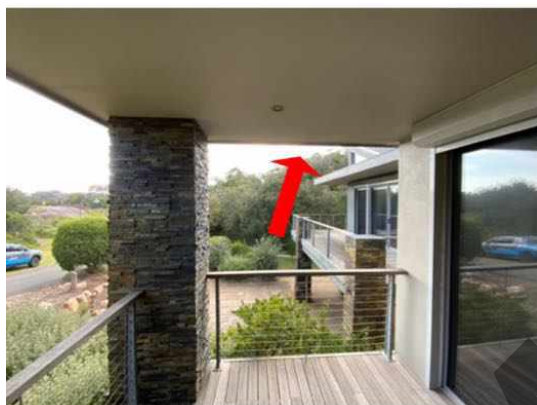
Defects 3.06

Finding: Sealant - Deteriorated

Information: It was noted on inspection that sealant is degraded to areas of the external eaves. Flexible and mould resistant materials should be applied to affected areas to prevent any subsequent water damage that is likely to occur.

Regular maintenance and replacement of damage or missing or damaged sealant is highly recommended to the eave areas, as this is a regular wear and tear defect. A sealant specialist or general handyman should be appointed to complete these works as soon as possible.

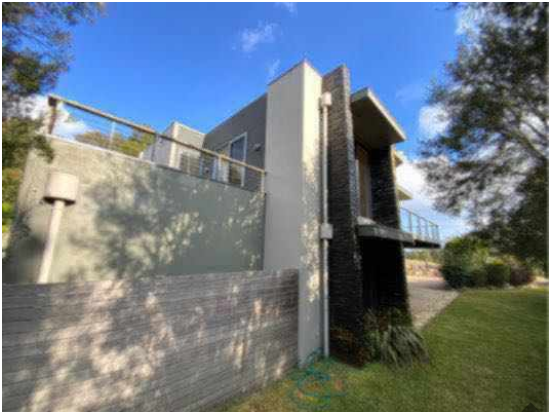
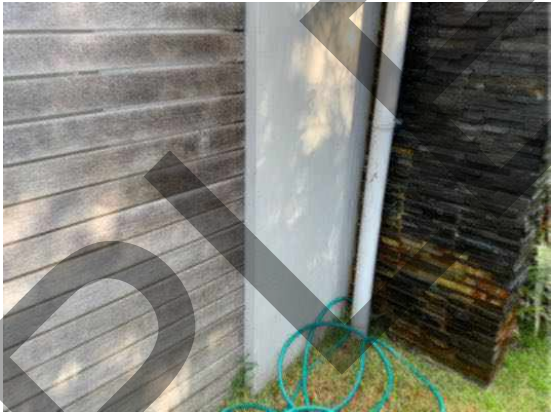
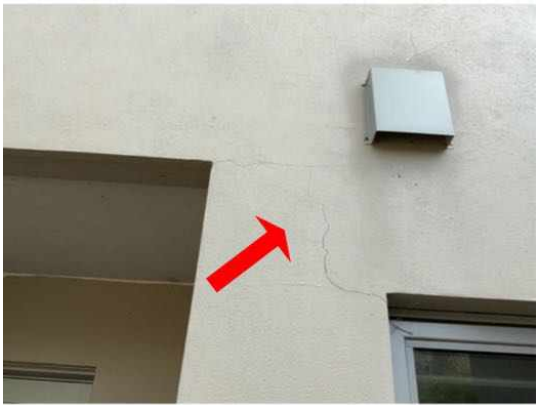
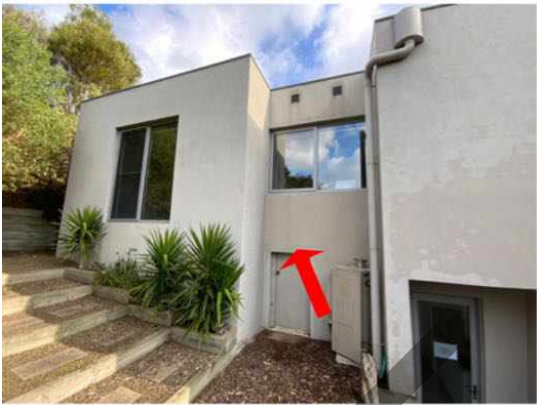
Defects 3.07

Building:	Main Building
Location:	All External Areas
Finding:	Brickwork/Render - Cracking Noticeable
Information:	There was extensive cracking to the external brickwork and rendered finishes at the time of inspection. Noticeable cracks are a common occurrence in brickwork and rendered finishes are a likely result of age expected building movement, general expansion, and/or contraction of building materials in different weather conditions. Noticeable cracks in brickwork and render may develop if left unattended, with potential for necessitating major remedial works or replacement of the brickwork.

It is highly advised that a registered building practitioner be appointed to further assess the affected areas and to provide necessary works to cracked to prevent any further damage. Such works should be conducted as soon as possible.

Always monitor these cracks and contact a structural engineer or a building consultant should cracks widen, lengthen, or become more numerous.

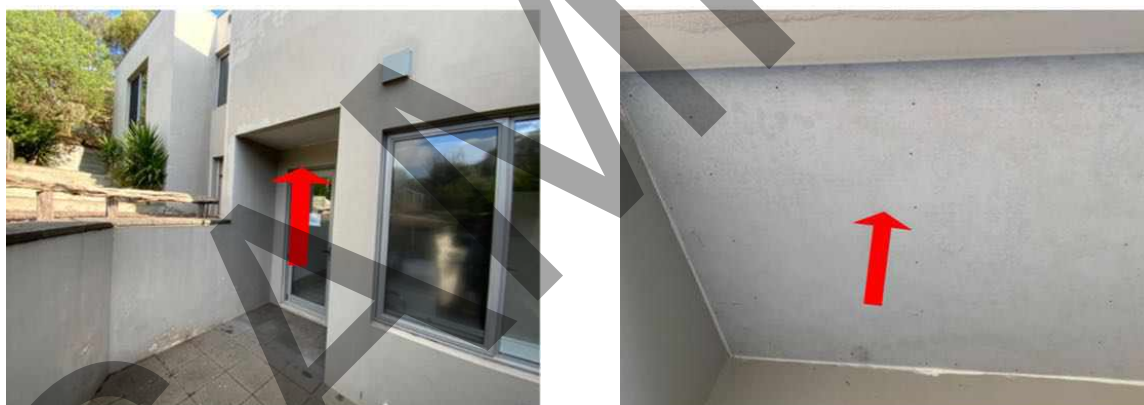
Defects 3.08

Building:	Main Building
Location:	Rear Elevation
Finding:	Paint finish - Incomplete
Information:	The paint finish to the eave area was identified as being incomplete at the time of inspection.

Whilst incomplete or missing paint finish is generally an appearance defect, it can also lead to the development of secondary building defects over time. Incomplete areas of paint finish expose the area to moisture, potentially accelerating the deterioration of underlying building materials.

Where inadequate or missing paint protection has led to the deterioration of the associated building element, repair and/or replacement of this building element may be required.

A painting contractor should be appointed as soon as possible to perform necessary works to aid the appearance of the affected area and to ensure the area is protected against further deterioration. Alternatively, the homeowner following manufacturer instructions may perform these works.

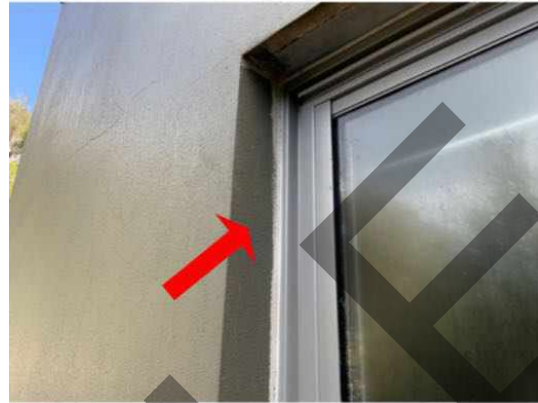
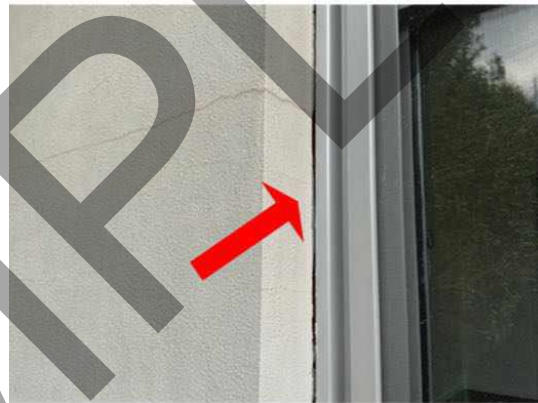
Defects 3.09

Building:	Main Building
Location:	All External Areas
Finding:	Window Sealant - Deteriorated
Information:	The window sealants have deteriorated to sections of the external window frames. Due to frequent exposure to weather conditions and subsequent moisture, deterioration of window sealants is expected in a property of this condition and age.

Where window sealants have deteriorated, the window is no longer weather-tight; rain penetration and subsequent water damage is therefore likely to ensue. Insulation of the area against external weather conditions will also be compromised.

It is recommended that all deteriorated window sealants be replaced by a sealant expert to prevent any further damage and to restore the window to a fully functional level.

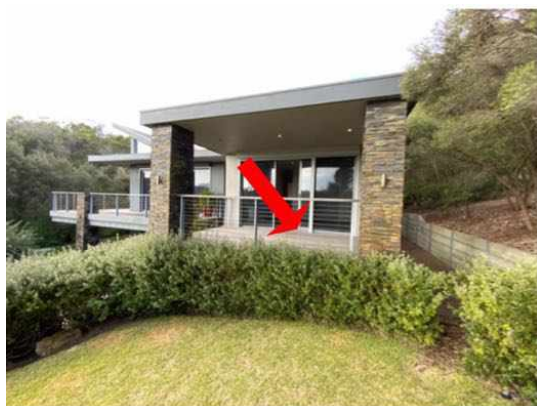
Defects 3.11

Building:	Main Building
Location:	Balcony
Finding:	Decking Structure - Wood Rot
Information:	The decking structures are showing signs of deterioration and wood rot (fungal decay) of the timbers. It is suspected that this defect has developed as a result of damp conditions in the subfloor. Damp conditions cause the timbers to fail, resulting in the decking structures failing to bear the load (or weight) of the building as originally intended.

Without repairs and maintenance, including potential replacement of affected elements, it is likely that serious structural faults will result, as well as an array of minor defects. The presence of wood rot to the decking structure is also conducive to termite infestation. As the decking timber is in sections are in direct contact with the ground, concealed termite is made possible. Such entry is made easier if the timbers become non-durable due to even slight wood rot.

Where wood rot is present to any timber, rectification or replacement of the affected timber building element is required. The adequate timeframe for such works are dependent on the severity of the rot. Where rot has developed to become widespread, replacement of sections of the subfloor structure may be required. Consultation with a registered building practitioner is highly advised to conduct repairs as soon as possible.

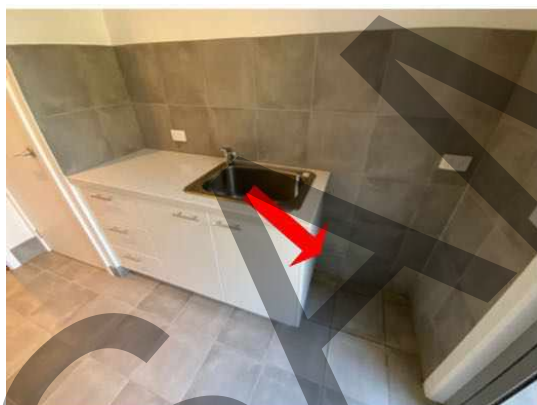
Defects 3.12

Building: Main Building
 Location: Laundry
 Finding: Grout - Missing
 Information: Grout is missing to sections of the laundry floor at the time of inspection. Grout is used to protect gaps and crevices in building materials to ensure that they are water-tight and prevent water penetration to the associated structures.

Where grout is missing, a tiling contractor should be appointed immediately to apply grout and re-apply any silicone where necessary. Failure to do so is likely to lead to water damage to the surrounding area.

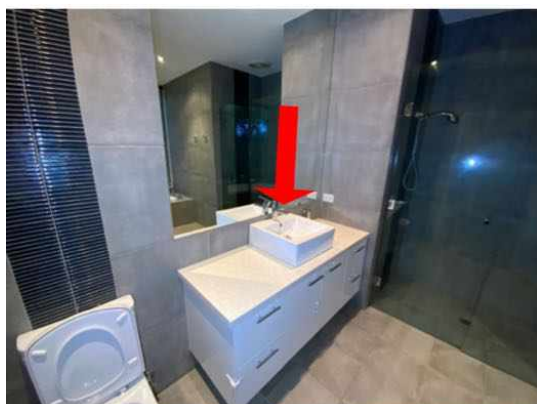
Defects 3.13

Building: Main Building
 Location: Ensuite - Master
 Finding: Basin - Cracked
 Information: Cracking was evident to the basin at the time of inspection, which is suspected to have been by minor impact damage. While the cracking appears to be minor, any further impact damage sustained by the basin may lead to additional cracking.

As the cracking provides potential ingress for water, secondary water damage may

occur to associated cabinetry, walls or flooring, if the cracking is left unmanaged.

Consultation with a licensed plumber regarding basin repair or replacement is required. Remedial works may be required to protect against any further damage.

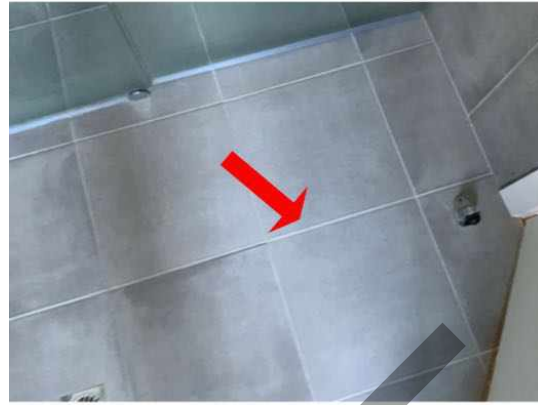
Defects 3.14

Building:	Main Building
Location:	Bathroom > Lower-Ground Level
Finding:	Tiles - Drummy
Information:	Drummy tiled areas were identified at the time of inspection. The term 'drummy' refers to tiles that have become detached from their fixing, despite otherwise being in relatively good condition. Such defects are generally caused by physical or moisture damage to the area. Drummy tiled areas may also be a direct result of poor workmanship during the construction process.

Tiled areas may swell and shrink with changes in air humidity if the area has sustained moisture damage. Any exposure to moisture is capable of causing tiled areas to become drummy and/or cracked over a prolonged period of time. Drummy tiled areas generally require removal and replacement of affected tiles, with adequate sealant and grouting.

Specialist trades are available for these types of services. A registered building practitioner may be required to undertake works if damage is extensive or if secondary building defects have resulted. Otherwise, it is advised that a tiling contractor be appointed to perform works as necessary. Immediate action is recommended to ensure that no further damage is sustained in the affected area.

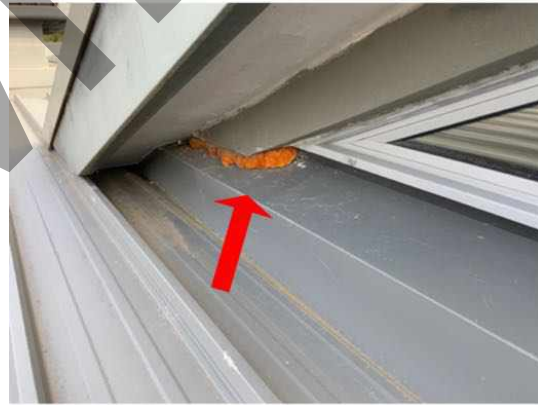
Defects 3.15

Building: Main Building
 Location: Roof Exterior
 Finding: Roof Flashing - Non Standard
 Information: The application of expanding foam to this section of the roof flashing does not appear to comply with current building practices.

A qualified roofing plumber should be appointed immediately to further inspect the affected flashing and replace any building elements that are required to keep the roof area water tight.

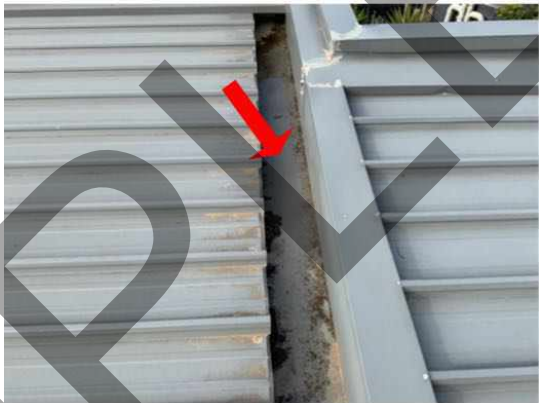
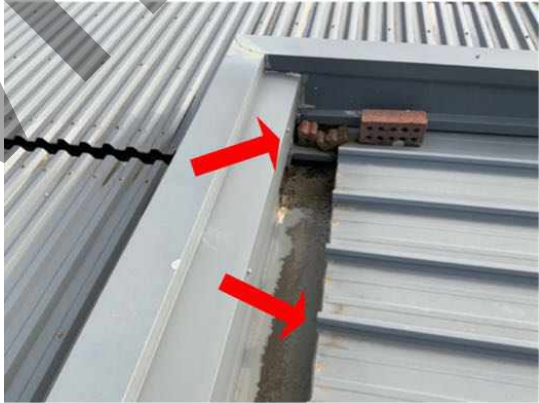
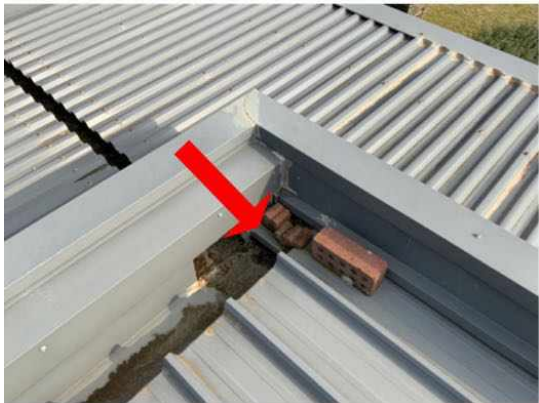
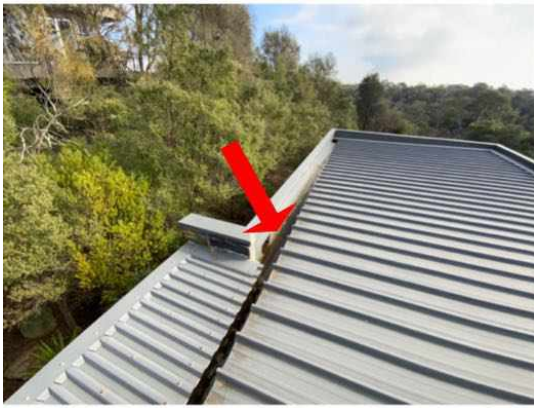
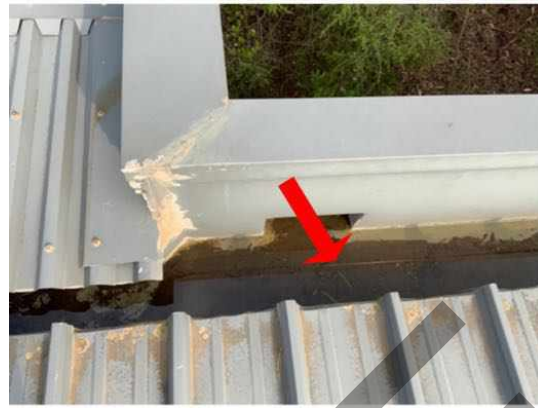
Defects 3.16

Building: Main Building
 Location: Roof Exterior
 Finding: Gutters - Water pooling
 Information: Water was found to be pooling in sections of the roof guttering. This is generally a secondary defect caused by blocked or partially blocked gutters. Such blockages and subsequent water pooling are likely to lead to rust and water damage to associated structures if left unattended.

partial or full blockages and any secondary damage that may have occurred as a result.

Depending on the extent of the damage, building elements may require repair and/or replacement to ensure adequate roof drainage and function of exterior plumbing system. The removal of bricks that have been used to secure flashing should also be conducted. If roof sections are found to be loose they should be fixed directly to the adjoining structures.

A roofing plumber should be appointed as soon as possible to rectify this issue. It is highly advised that all gutters be maintained on a frequent basis to ensure the condition of roof plumbing.

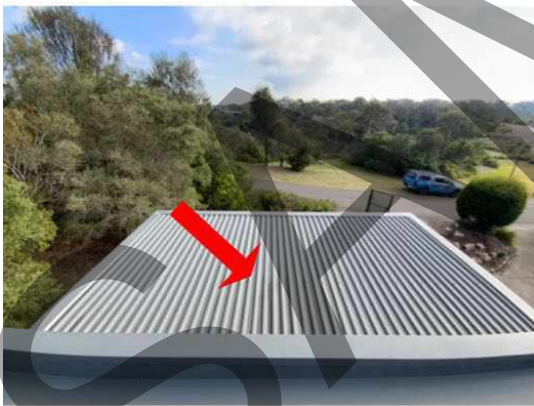
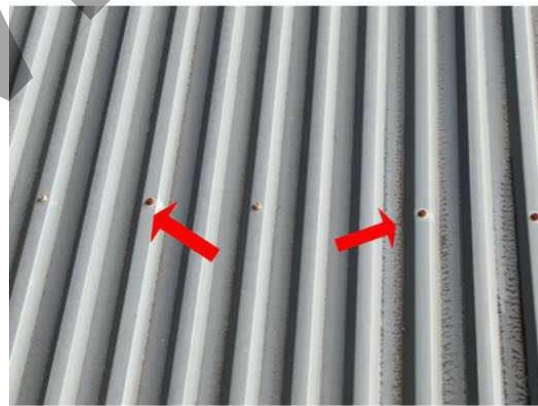
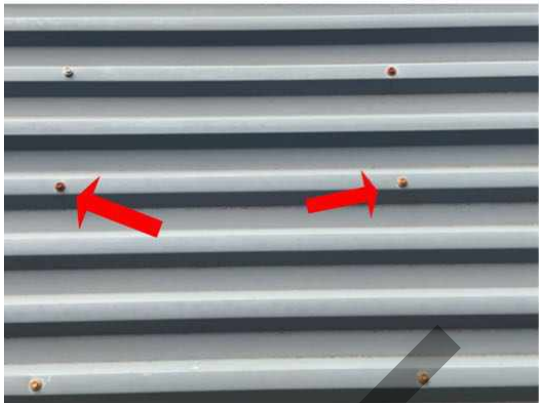
Defects 3.17

Building: Main Building
 Location: Roof Exterior
 Finding: Roof Fixings - Rusted
 Information: The roof fixings show areas of rust and corrosion. Rusted roof plumbing will generally develop holes and leaks that can affect other building elements with poor drainage of storm water. Repair and/or replacement of rusted roof fixings is required in order to reinstate the roof to a fully operational level.

A licensed plumber or specialist roof restoration company should be appointed to undertake these works. It is advised that such works be completed as soon as possible to prevent any further damage and deterioration.

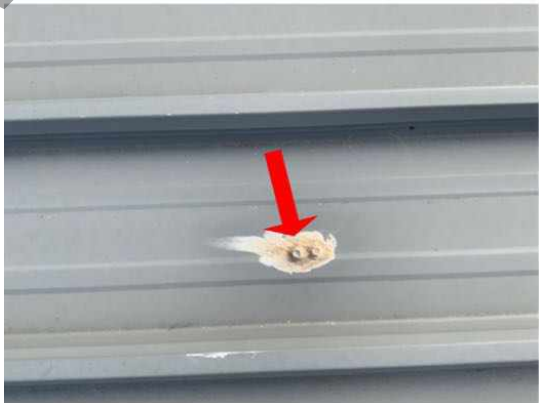
Defects 3.18

Building: Main Building
 Location: Roof Exterior
 Finding: Silicone Application - Excessive
 Information: The silicone repair work performed to the roof fixings appears to have been completed to an unsatisfactory standard. Excess silicone was evident in sections of the roof area providing a blemish on the appearance as well as detracting from the drainage of the area.

While weather-tight the excess silicone should be removed in order to increase drainage and to prevent accelerated deterioration of the adjoining materials. Replacement to sections of the roof sheeting may be required if excessive holes are found.

A roofing contractor may be appointed to perform these works at client discretion.

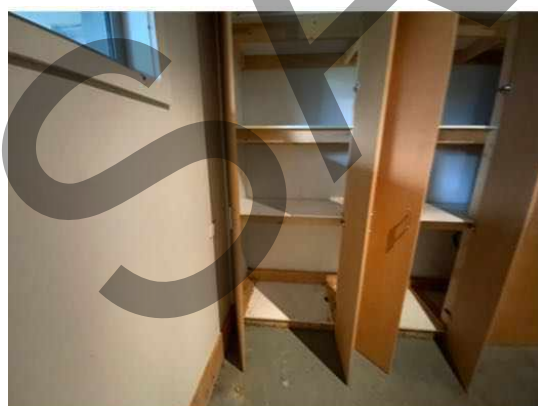
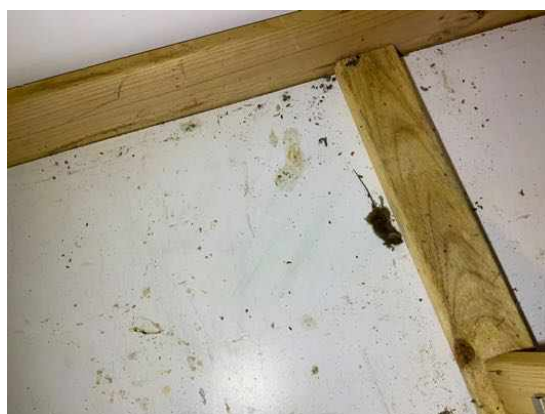
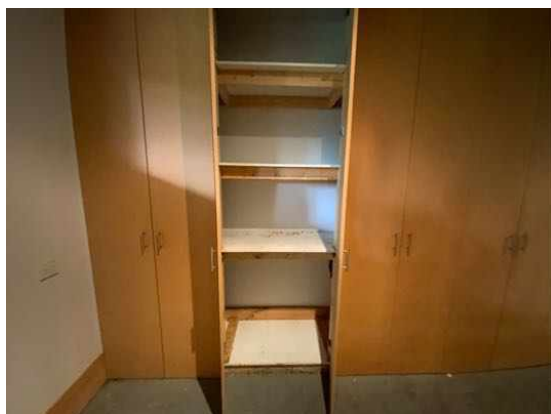
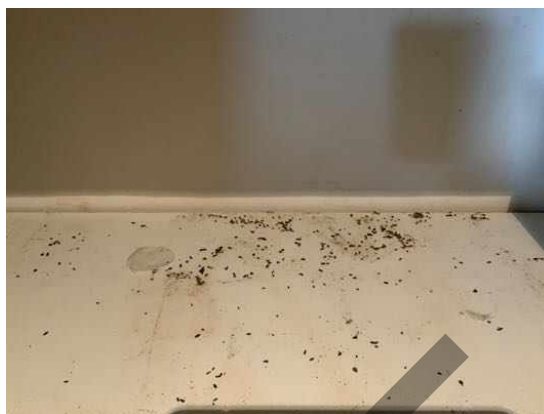
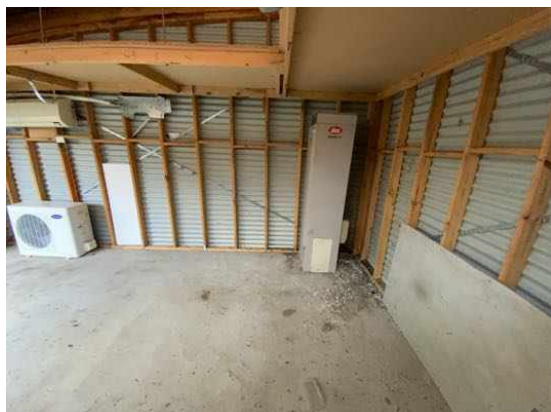
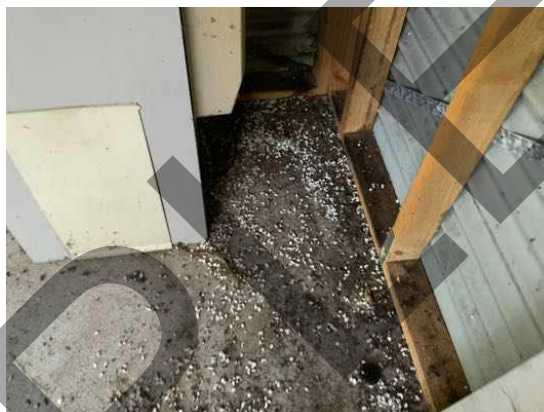
Noted Item

Building: Main Building
Location: Shed - Garage
Finding: Pest Infestation
Information: There was evidence of pest infestation observed in the rear shed and garage areas at the time of inspection. It is recommended that a further inspection of the property be conducted by licensed pest controller.

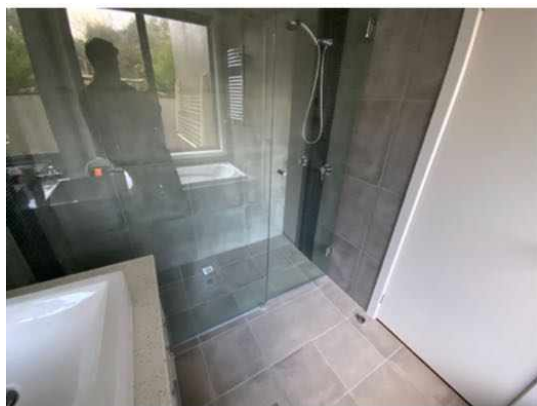
Noted Item

Building: Main Building
 Location: Bathroom > Lower-Ground Level
 Finding: Shower Alcove - Inspection
 Information: There was no visible evidence of water escape from the accessible areas around the bathroom shower alcove area in the ground floor area at the time of inspection. Plasterboard walls, ceilings, carpet, furniture, cabinetry or timber skirting adjoining the shower alcove showed no evidence of water staining or damage at the time of inspection.

If there are any signs of deterioration to sealants and grout, cracked tiles or bases, water damage or water escape a registered building practitioner should be immediately engaged.
