Building Inspection Report

Inspection Date: Sat, 10 Jul 2021

Property Address: SAMPLE REPORT - PRE PURCHASE

Company Name: Jim's Building Inspections

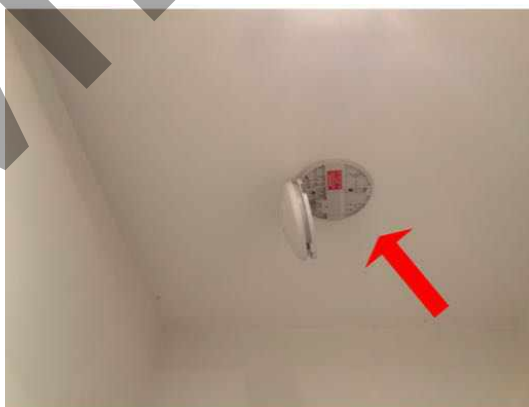
Defects 1.01

Please note that this defect is highlighted as a caution only. We suspect, based on our experience in the building industry, that the absence of smoke detectors, or their poor condition, should be addressed as a matter of urgency to improve occupant safety.

Further Inspection and/or advisory services is necessary to provide advice on the sufficiency, type and location of smoke detectors, and to test the functionality of all devices.

Always ensure sufficient working and suitable smoke detectors are installed prior to occupying any building.

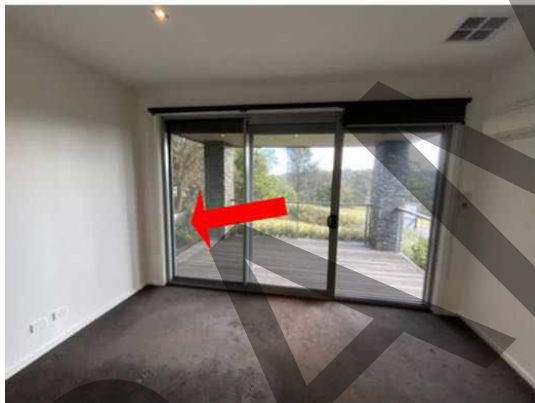
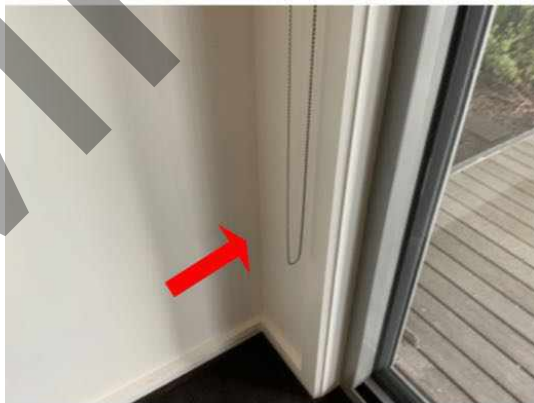
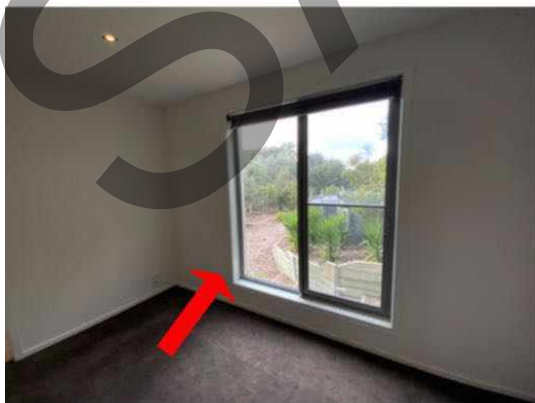
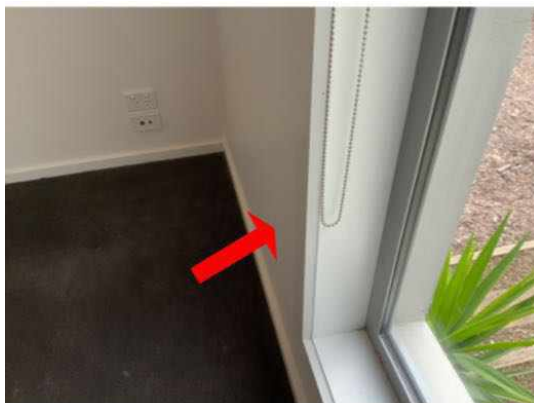
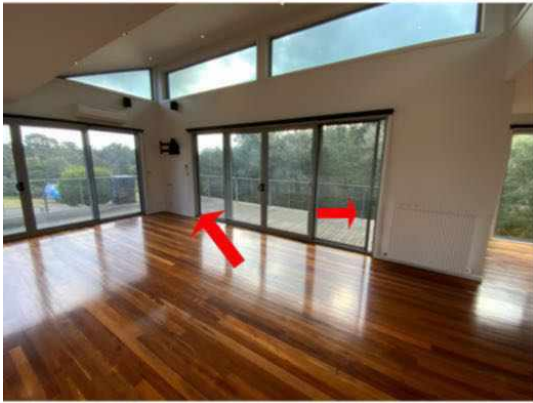
Defects 1.02

Building:	Main Building
Location:	All Internal Areas
Finding:	Curtain & Blind - Safety Cord
Information:	Looped curtain and blind cords pose a significant strangulation hazard for children as they can place the loop over their head and/or get tangled in the loose cords. The mandatory standard for blinds, curtains and window fittings (in place from 30th December 2010) requires all new window furnishings to come with warning labels and to be installed with tensioning devices. However, as this standard is not retrospective,

Check all the rooms in your house for any blinds or curtains with long cords that are either loose or looped. This includes any cords that are within children's reach at floor level or near furniture they can climb on. Secure any loose or looped cords with cleats or tension devices – these can be purchased from your local curtain and blind retailer or hardware store.

Do not put furniture such as cots, beds, highchairs, playpens, couches, chairs, tables or bookshelves near a window where children can reach the blind or curtain cord. When installing new blinds and curtains, make sure you or the installer secures any loose or looped cords immediately.

Depending on the types of curtains/blinds that you have in your home, there are various kits and devices that can help you to make them safe. These can be purchased from your local hardware store or curtain and blind retailer.

It's recommended that this defect be resolved immediately to avoid harm to occupants. Consumer Affairs Victoria can be contacted for further information and have free curtain and blind cord kits that are suitable for roller blinds with looped cords and wooden window frames.

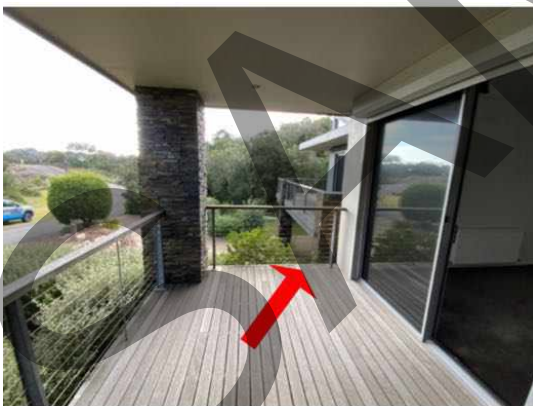
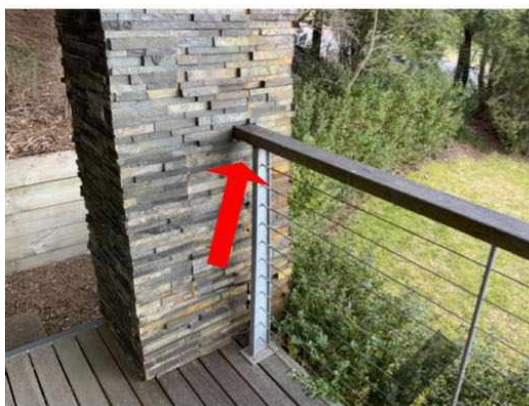
Defects 1.03

Finding: Balustrade Handrail - Loose

Information: Upon inspection of the balcony balustrade outside the master bedroom, it was noted that the handrail is loose and has excessive movement. It is suspected that this defect has developed as a result of a lack of adequate maintenance, but may also have been caused by inappropriate fixings being used in the construction process.

If left unaddressed, it is likely that secondary damage to associated building elements will develop, potentially necessitating remedial works to the wall structure. A balustrade contractor should be appointed to advise on rectification options. It is advised that remedial works be performed as soon as possible to prevent any further damage or unsafe conditions during use of the balcony.

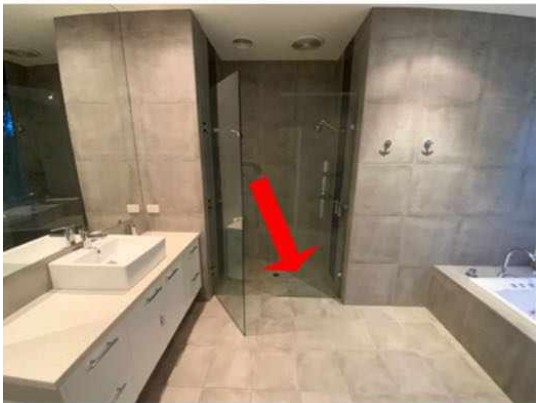
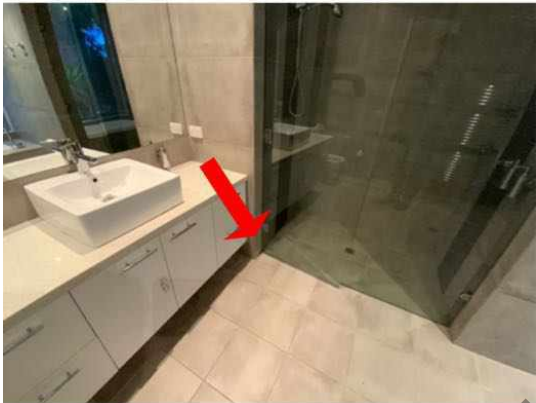
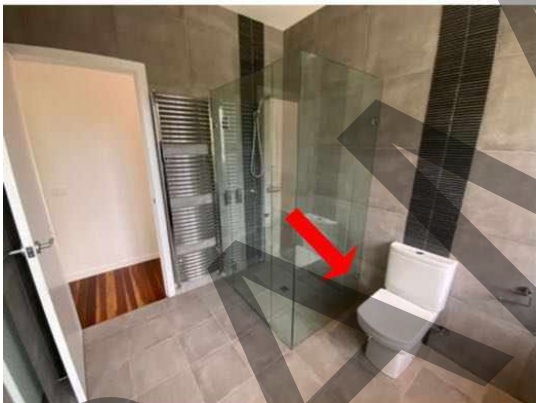
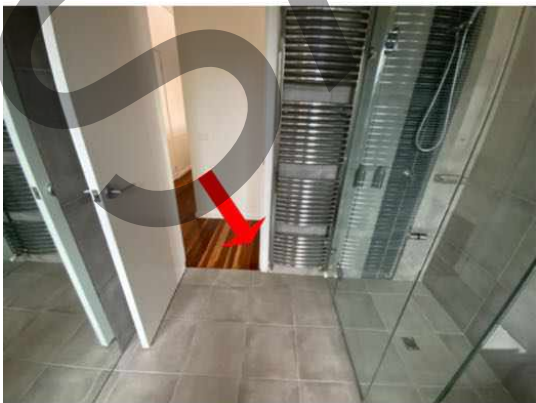
Defects 2.01

Building:	Main Building
Location:	Bathroom - Ensuite
Finding:	Shower Alcoves - Suspected Leak
Information:	It is suspected that leaking from the master bedroom ensuite and bathroom shower alcoves has occurred at the time of inspection. Moisture readings taken outside the shower alcove areas indicated elevated dampness. Distorted paint on the bathroom door jamb also indicates that moisture is trapped below the tiled flooring.

This defect is quite common, and is suspected to have been caused by defective waterproofing within the shower alcove areas. It is suspected that water stops have not been installed around the shower alcove perimeter.

Moisture permeating through the grouting and sealants in the shower alcove may also be a contributing factor. Unmanaged dampness is likely to facilitate the formation and development of mould and fungi growth, decaying associated building materials and compromising their structural integrity.

Consultation with a registered building practitioner is advised immediately to identify the cause of dampness and to perform remedial works as required.

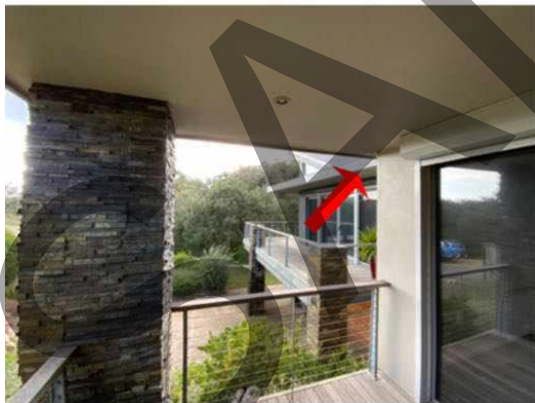
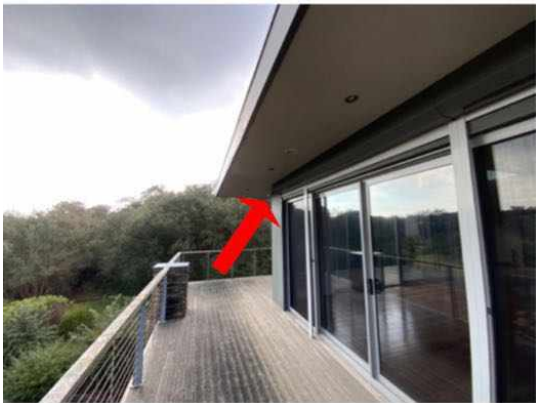
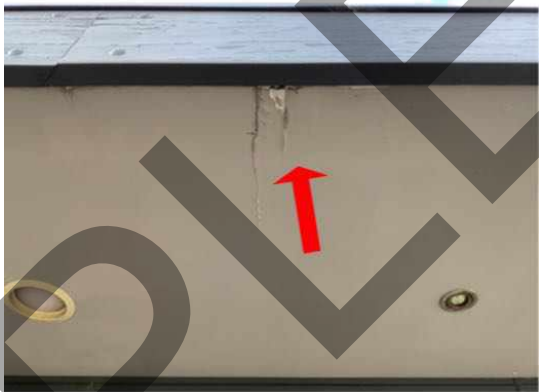
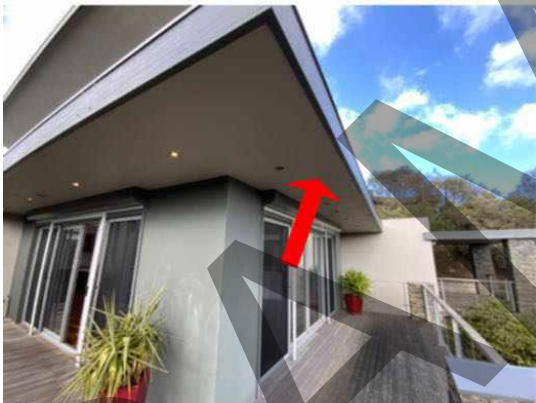
Defects 2.02

Building: Main Building
Location: All Areas
Finding: Eave Sheeting - Water Stained & Cracked
Information: Water staining and cracking to eave linings at the front and side elevations of the property was evident at the time of inspection. Water staining indicates that surfaces have been exposed to excessive moisture over time. Cracking indicates that there has been expansion and contraction of the eave structure.

Water staining can be indicative of more serious defects, which may be currently concealed by the eave linings or external roof tiles. Where water staining is active, a licensed plumber must be consulted to identify the cause of the staining and to provide advice on any reparation works that may be required.

Replacement of any damaged structures is advised and should be completed by a registered building practitioner.

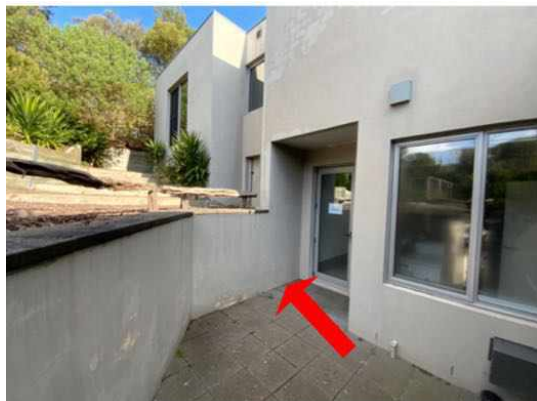
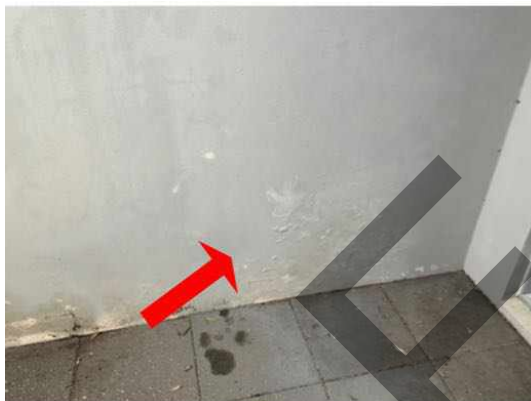
Defects 2.03

Building: Main Building
 Location: Rear Elevation
 Finding: Retaining Wall Waterproofing - Defective
 Information: There was evidence of bubbling render and excessive moisture to the external retaining wall adjacent to the laundry area.

It is recommend that a registered building practioner be engaged to conduct a further

excavation of the perimeter retaining walls to further assess the affected areas and to provide costs for the required rectification works.

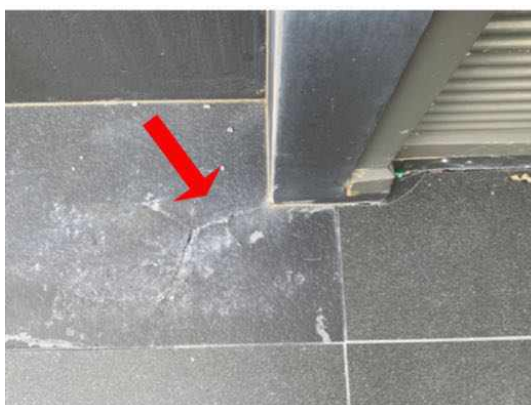
Defects 2.04

Building: Main Building
Location: Rear Balcony
Finding: Cracked Balcony Tiles
Information: Cracking to the balcony floor tiles was evident at the time of inspection. It is suspected that this cracking has occurred as a result of minor settlement or shrinkage of the balcony substructure. Substandard installation of the balcony waterproofing system may also be a contributing factor. Cracked tiles on a balcony detract from the overall appearance of the affected areas and may lead to secondary defects occurring.

A registered building practitioner should be immediately appointed to further assess and perform rectification works. The client should be aware that replacement of the balcony waterproofing system and tiling may be required as there was evidence of water damage to the bedroom ceiling below the balcony.

Where cracks become more numerous, immediately contact a structural engineer for a further investigation.

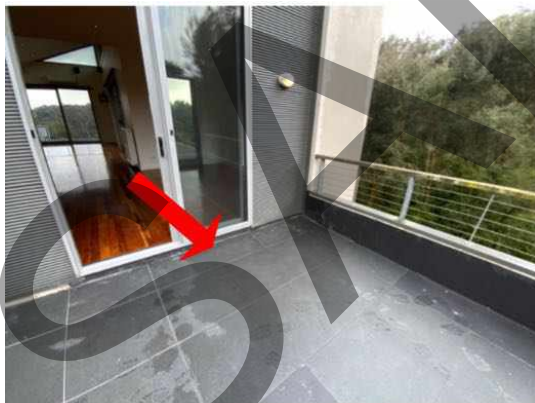
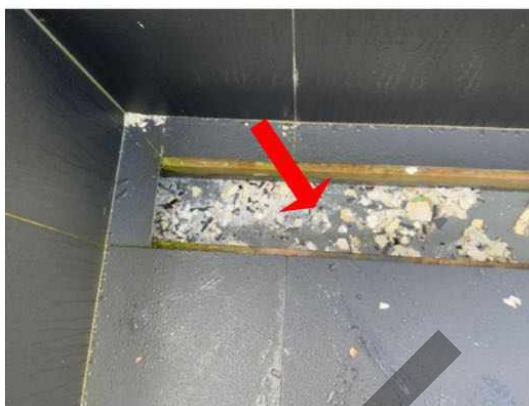
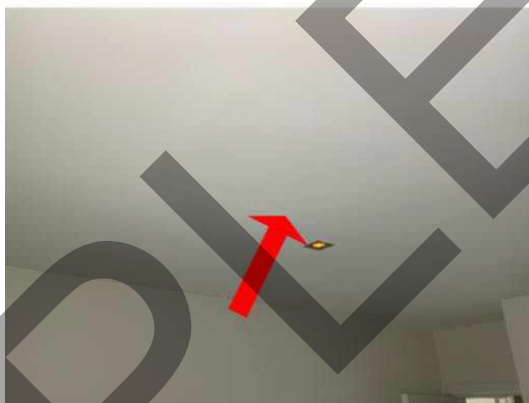
Defects 2.05

Building:	Main Building
Location:	Rear Balcony - Bedroom 4
Finding:	Evidence of Recent Repairs
Information:	There was evidence of recent repairs to the rear balcony area and to the bedroom 4 ceiling located below the balcony.

Where evidence of recent balcony repairs or plaster work is present, it is recommended that the vendor provide further information about the purpose of repairs. It is not uncommon for ceilings to be repaired below upper levels that may contain areas such as balconies if leaking has occurred.

If the vendor is not able to provide further information, a further invasive inspection of the ceiling void is recommended by a registered building practitioner.

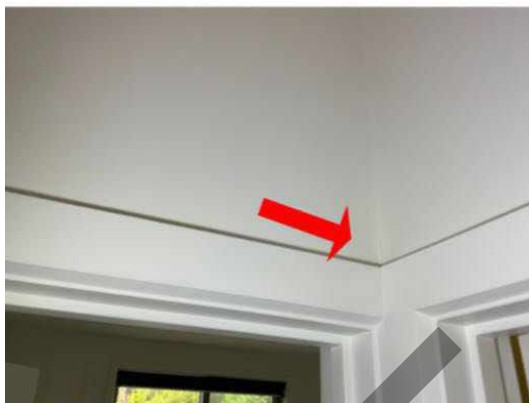
Defects 3.01

Building:	Main Building
Location:	Hall
Finding:	Cracking to internal Walls
Information:	Although cracks to sections of the internal walls are quite noticeable, they are often only considered to be an appearance defect, and usually do not indicate any structural damage. Generally, the cause of the cracks is due to general building movement, indicative of a separation between building materials and finishes (e.g. paint, plaster, etc.) along joints.

Cracking of this nature can generally be repaired with minor sanding, filling and/or repainting. Such works should be performed by a qualified painter or a plastering contractor.

Monitoring of all cracking should be conducted frequently. Always contact a building consultant should cracks widen, lengthen, or become more numerous.

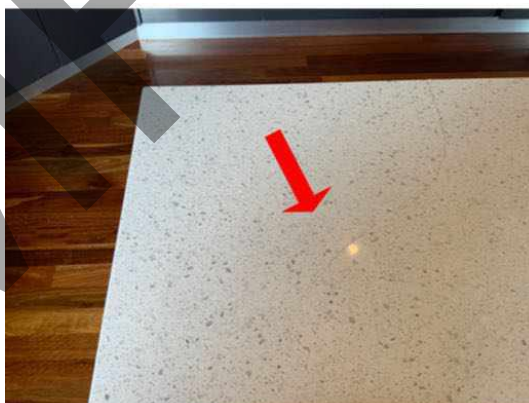
Defects 3.02

Building: Main Building
 Location: Kitchen
 Finding: Bench Top - Cracked
 Information: Cracking to the edge of the kitchen benchtop was observed at the time of inspection.

It is recommended that a benchtop specialist be engaged to assess the crack and to carry out further repairs to avoid further deterioration of the bench top.

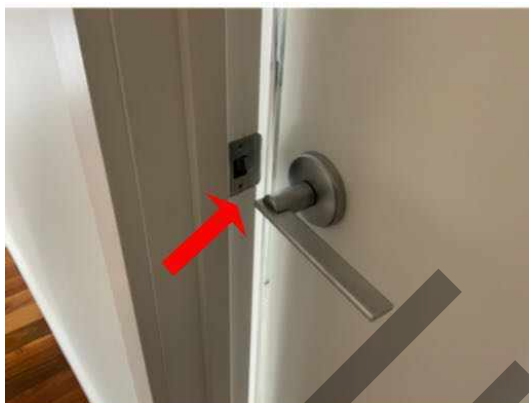
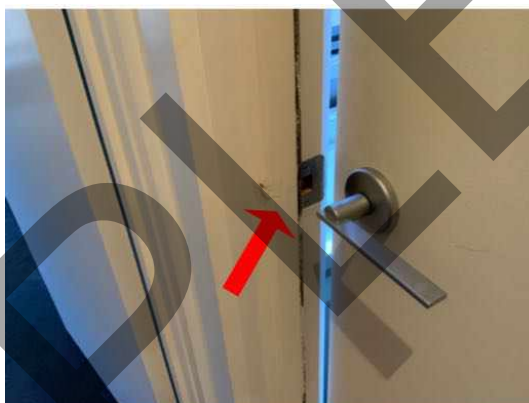
Defects 3.03

Building: Main Building
 Location: All Internal Areas
 Finding: Door - Striker Plate Misaligned
 Information: The striker plate to several internal doors appear to have become misaligned and has consequently resulted in the door's operation being compromised.

This is a common defect and is expected in a property of this age, whether being due to substandard installation or general deterioration of the door hardware.

Readjustment of the striker plate is recommended at client discretion.

Works such as these can be completed by a general handyman or qualified carpenter.

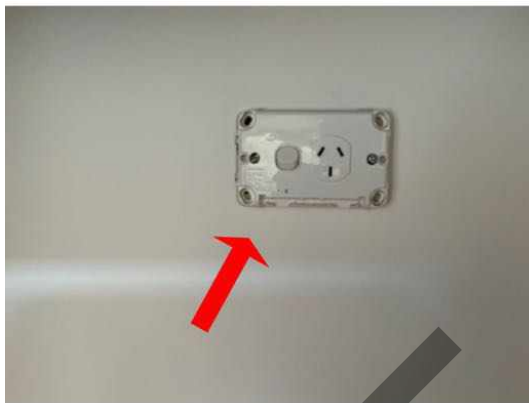
Defects 3.04

Building:	Main Building
Location:	Kitchen
Finding:	Power Point - Cover Plate Missing
Information:	The power point cover plate was found to be missing in this area at the time of inspection. Although some building elements may seem irrelevant or unnecessary, all building elements play a key role in the operation and function of the overall structure and its performance.

Replacement of any missing building element should be conducted as soon as possible to ensure that no damage or functional issues occur to associated building materials. A licensed electrician should be appointed to install a new power point cover plate as soon as possible.

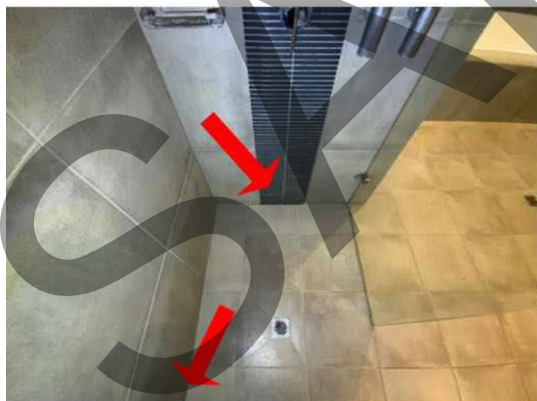
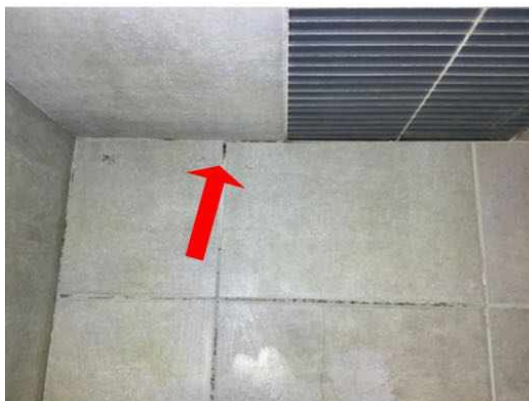
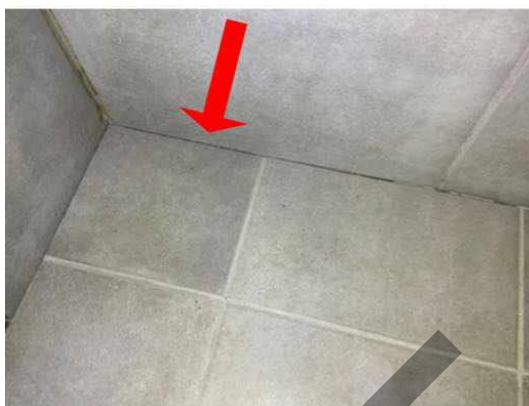
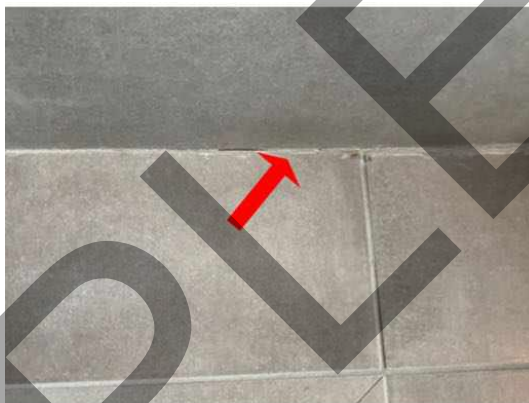
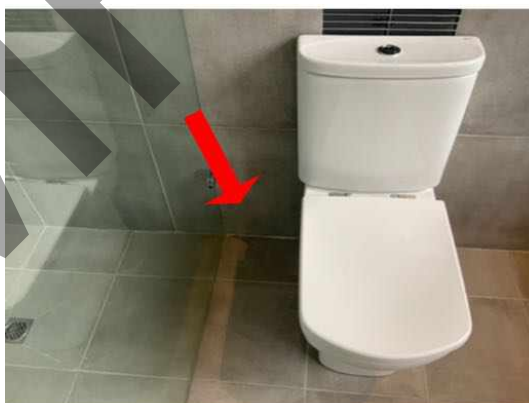
Defects 3.05

Building: Main Building
 Location: Bathroom - Ensuite
 Finding: Shower Alcove - Sealant & Grout Deteriorated
 Information: There appears to be deterioration of the grout and sealants in the shower alcove areas of the master bedroom ensuite and upstairs bathroom. This type of deterioration typically occurs when excess moisture is trapped below the tiles and within the waterproofing system.

This type of deterioration can be an indication of defective waterproofing if located in areas such as shower alcoves or bathroom tiling.

A registered building practitioner should be engaged to further assess the affected shower alcove areas and provide recommendations on required rectification works. This defect should not be left unattended as water escape from the shower alcove and further deterioration of the grouting and tiled areas may occur.

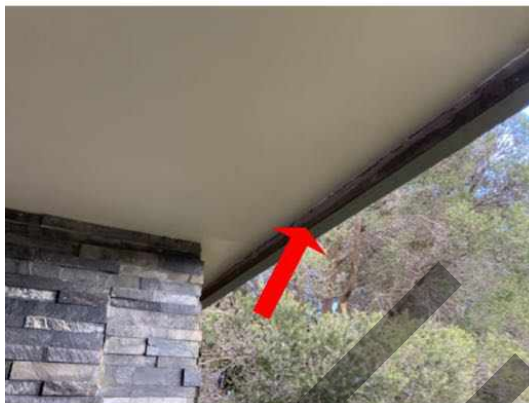
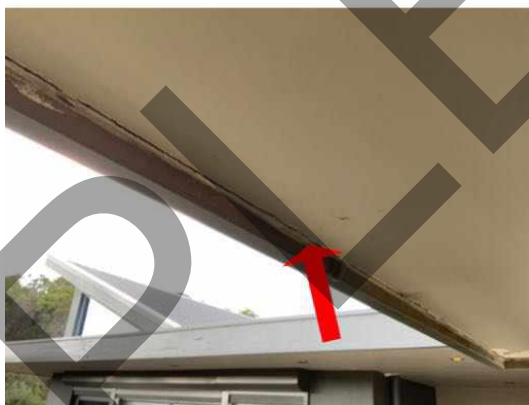
Defects 3.06

Finding: Sealant - Deteriorated

Information: It was noted on inspection that sealant is degraded to areas of the external eaves. Flexible and mould resistant materials should be applied to affected areas to prevent any subsequent water damage that is likely to occur.

Regular maintenance and replacement of damage or missing or damaged sealant is highly recommended to the eave areas, as this is a regular wear and tear defect. A sealant specialist or general handyman should be appointed to complete these works as soon as possible.

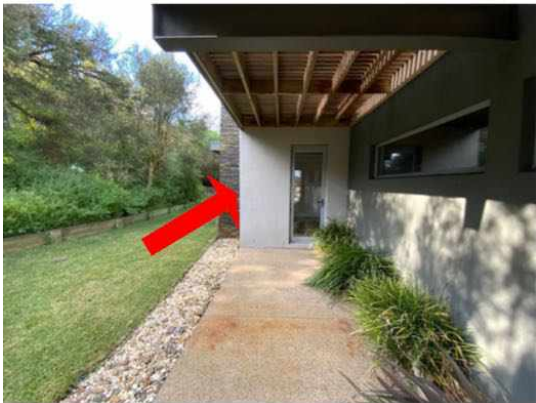
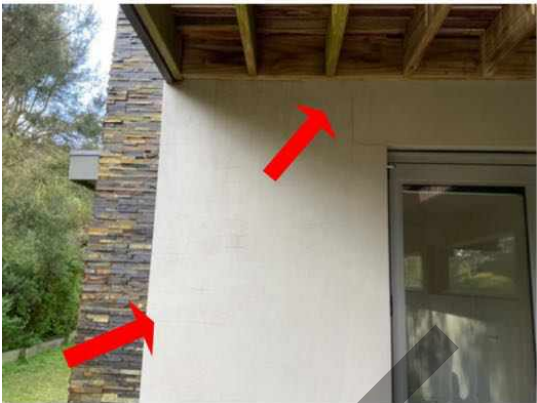
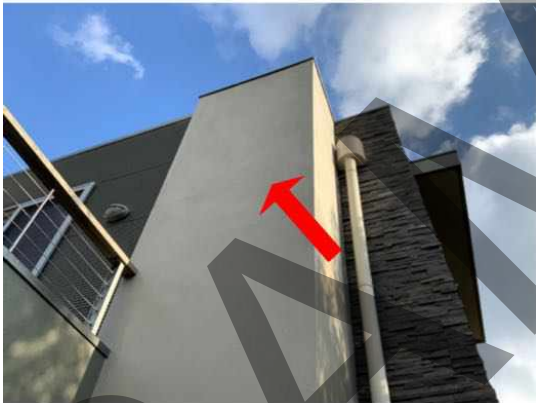
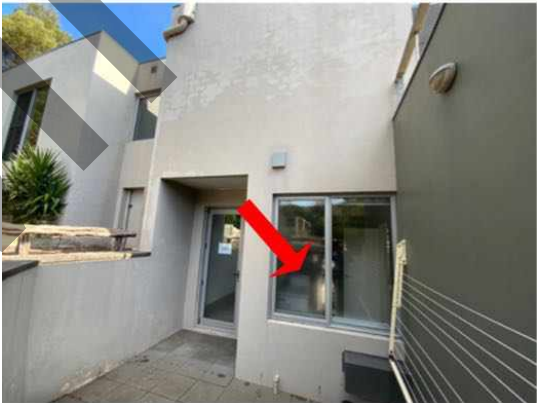
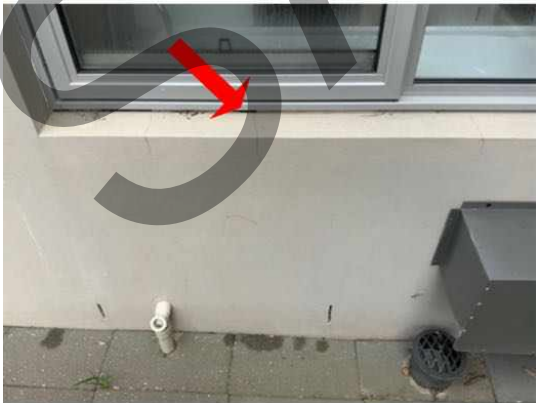
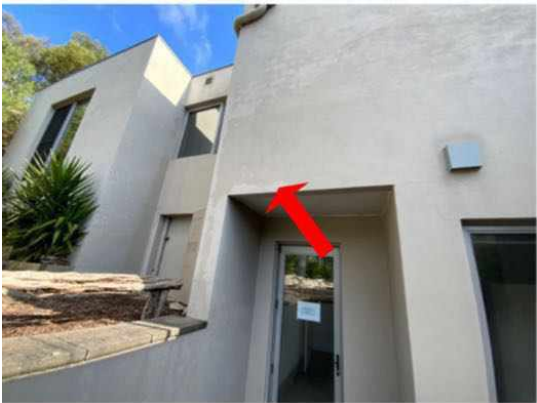
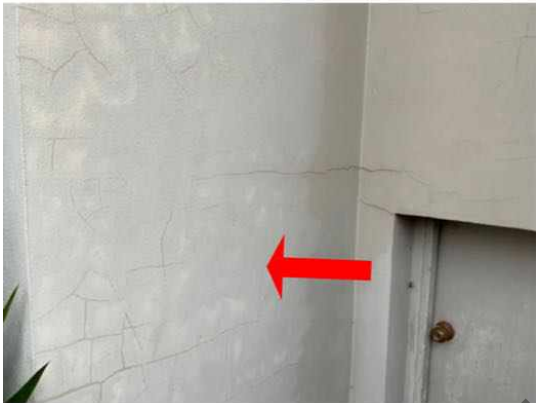
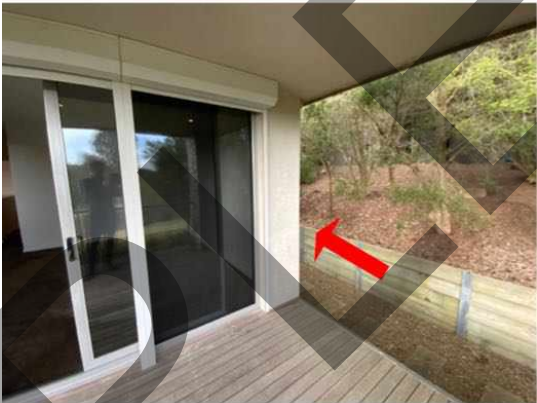
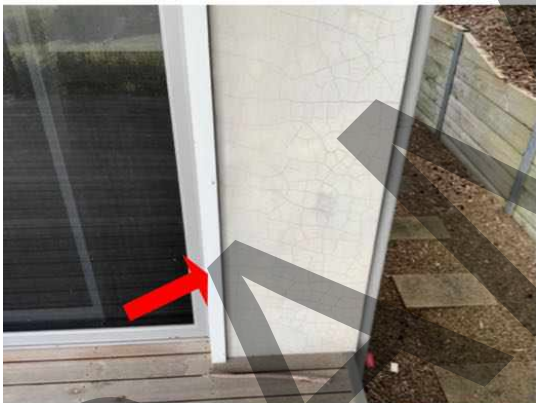
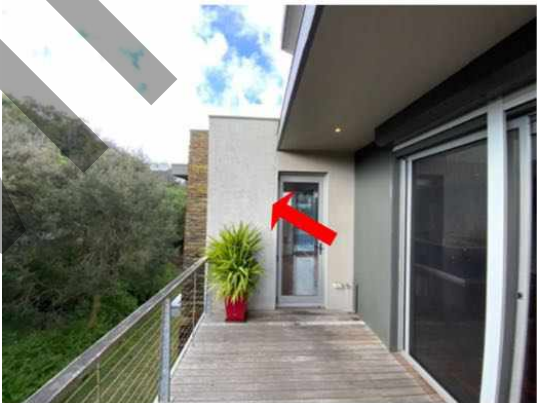
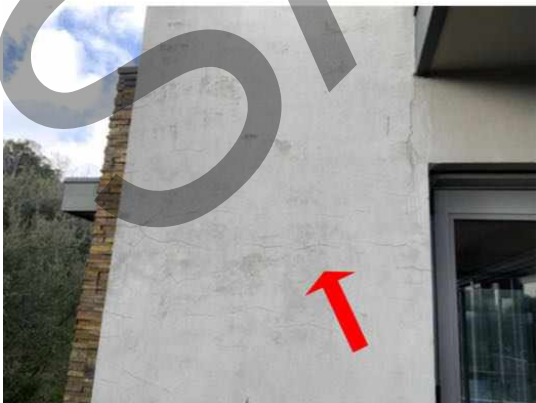
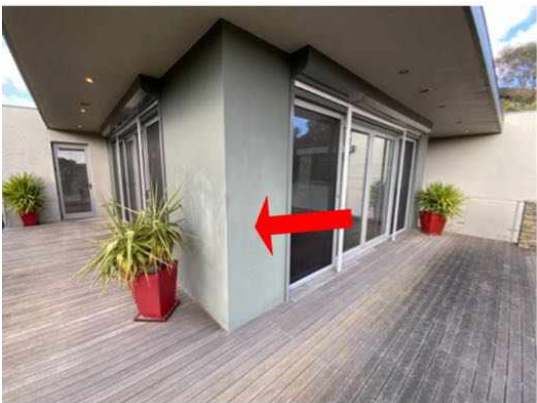
Defects 3.07

Building:	Main Building
Location:	All External Areas
Finding:	Brickwork/Render - Cracking Noticeable
Information:	There was extensive cracking to the external brickwork and rendered finishes at the time of inspection. Noticeable cracks are a common occurrence in brickwork and rendered finishes are a likely result of age expected building movement, general expansion, and/or contraction of building materials in different weather conditions. Noticeable cracks in brickwork and render may develop if left unattended, with potential for necessitating major remedial works or replacement of the brickwork.

It is highly advised that a registered building practitioner be appointed to further assess the affected areas and to provide necessary works to cracked to prevent any further damage. Such works should be conducted as soon as possible.

Always monitor these cracks and contact a structural engineer or a building consultant should cracks widen, lengthen, or become more numerous.

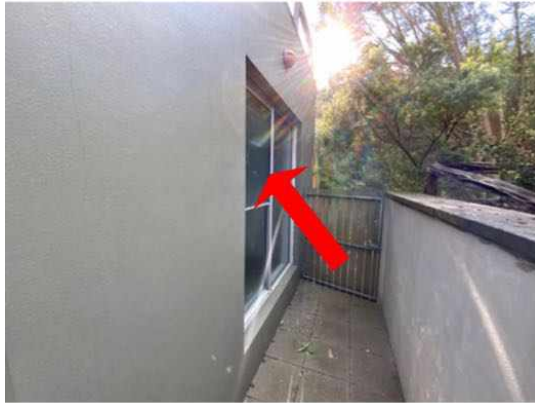
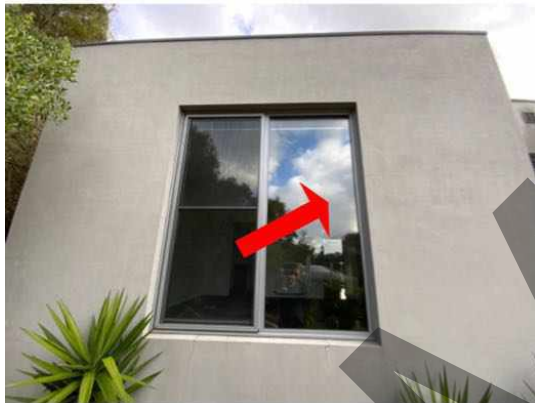
Defects 3.09

Building:	Main Building
Location:	All External Areas
Finding:	Window Sealant - Deteriorated
Information:	The window sealants have deteriorated to sections of the external window frames. Due to frequent exposure to weather conditions and subsequent moisture, deterioration of window sealants is expected in a property of this condition and age.

Where window sealants have deteriorated, the window is no longer weather-tight; rain penetration and subsequent water damage is therefore likely to ensue. Insulation of the area against external weather conditions will also be compromised.

It is recommended that all deteriorated window sealants be replaced by a sealant expert to prevent any further damage and to restore the window to a fully functional level.

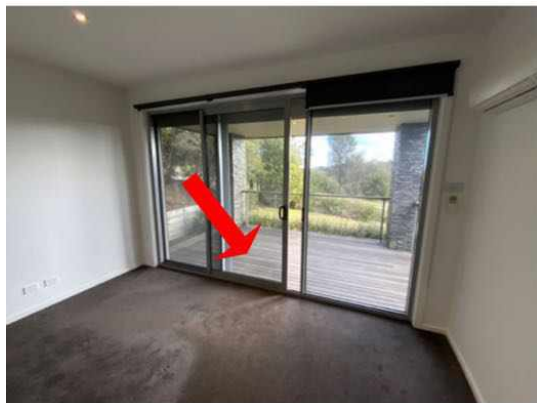
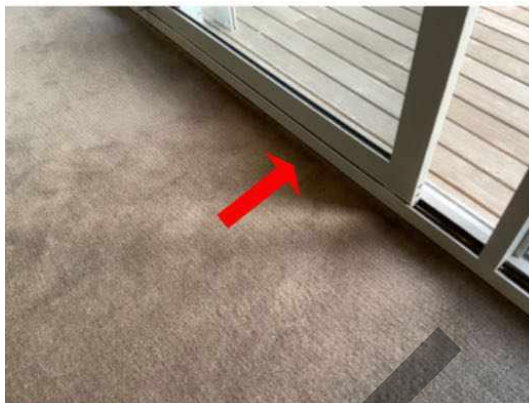
Defects 3.10

Building: Main Building
 Location: Bedroom - Master
 Finding: Sliding Door - Stiff to slide
 Information: The master bedroom door was jammed and difficult to slide along the associated tracks at the time of the inspection. Restricted function of the affected door may pose as a potential safety hazard if required for emergency egress from the building.

Generally, factors such as general age of the building element and a lack of maintenance are the usual causes for this type of defect.

Replacement of the sliding door hardware or tracks may be required, as well as minor repairs and cleaning.

A qualified carpenter will be required to repair the affected door.

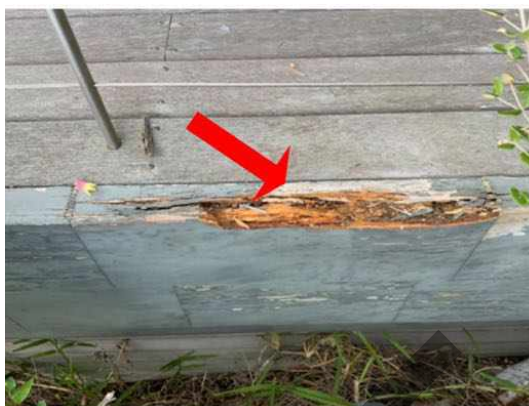
Defects 3.11

Building:	Main Building
Location:	Balcony
Finding:	Decking Structure - Wood Rot
Information:	The decking structures are showing signs of deterioration and wood rot (fungal decay) of the timbers. It is suspected that this defect has developed as a result of damp conditions in the subfloor. Damp conditions cause the timbers to fail, resulting in the decking structures failing to bear the load (or weight) of the building as originally intended.

Without repairs and maintenance, including potential replacement of affected elements, it is likely that serious structural faults will result, as well as an array of minor defects. The presence of wood rot to the decking structure is also conducive to termite infestation. As the decking timber is in sections are in direct contact with the ground, concealed termite is made possible. Such entry is made easier if the timbers become non-durable due to even slight wood rot.

Where wood rot is present to any timber, rectification or replacement of the affected timber building element is required. The adequate timeframe for such works are dependent on the severity of the rot. Where rot has developed to become widespread, replacement of sections of the subfloor structure may be required. Consultation with a registered building practitioner is highly advised to conduct repairs as soon as possible.

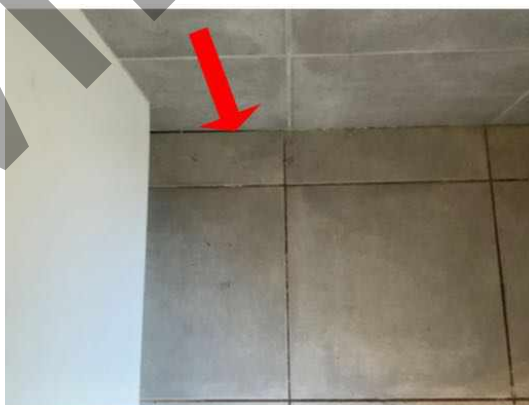
Defects 3.12

Building: Main Building
 Location: Laundry
 Finding: Grout - Missing
 Information: Grout is missing to sections of the laundry floor at the time of inspection. Grout is used to protect gaps and crevices in building materials to ensure that they are water-tight and prevent water penetration to the associated structures.

Where grout is missing, a tiling contractor should be appointed immediately to apply grout and re-apply any silicone where necessary. Failure to do so is likely to lead to water damage to the surrounding area.

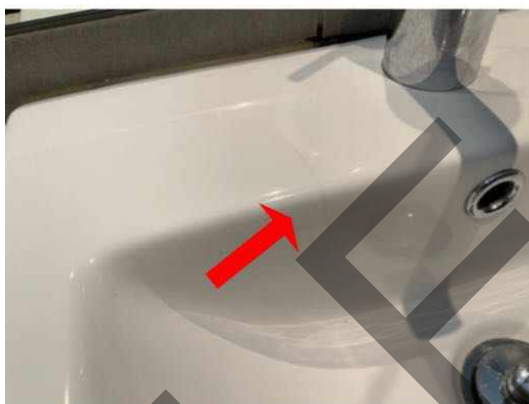
Defects 3.13

Building: Main Building
 Location: Ensuite - Master
 Finding: Basin - Cracked
 Information: Cracking was evident to the basin at the time of inspection, which is suspected to have been by minor impact damage. While the cracking appears to be minor, any further impact damage sustained by the basin may lead to additional cracking.

As the cracking provides potential ingress for water, secondary water damage may

occur to associated cabinetry, walls or flooring, if the cracking is left unmanaged.

Consultation with a licensed plumber regarding basin repair or replacement is required. Remedial works may be required to protect against any further damage.

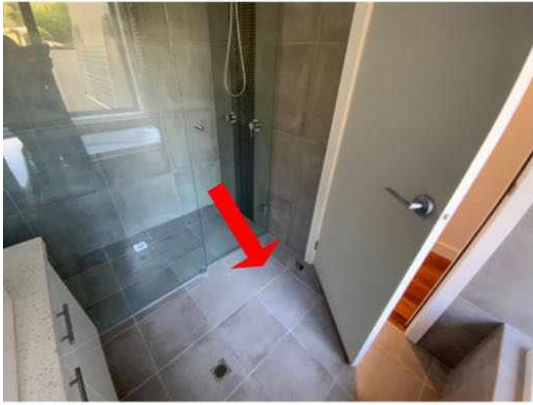
Defects 3.14

Building:	Main Building
Location:	Bathroom > Lower-Ground Level
Finding:	Tiles - Drummy
Information:	Drummy tiled areas were identified at the time of inspection. The term 'drummy' refers to tiles that have become detached from their fixing, despite otherwise being in relatively good condition. Such defects are generally caused by physical or moisture damage to the area. Drummy tiled areas may also be a direct result of poor workmanship during the construction process.

Tiled areas may swell and shrink with changes in air humidity if the area has sustained moisture damage. Any exposure to moisture is capable of causing tiled areas to become drummy and/or cracked over a prolonged period of time. Drummy tiled areas generally require removal and replacement of affected tiles, with adequate sealant and grouting.

Specialist trades are available for these types of services. A registered building practitioner may be required to undertake works if damage is extensive or if secondary building defects have resulted. Otherwise, it is advised that a tiling contractor be appointed to perform works as necessary. Immediate action is recommended to ensure that no further damage is sustained in the affected area.

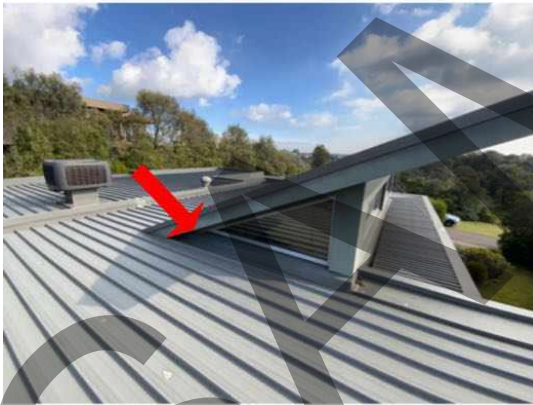
Defects 3.15

Building: Main Building
 Location: Roof Exterior
 Finding: Roof Flashing - Non Standard
 Information: The application of expanding foam to this section of the roof flashing does not appear to comply with current building practices.

A qualified roofing plumber should be appointed immediately to further inspect the affected flashing and replace any building elements that are required to keep the roof area water tight.

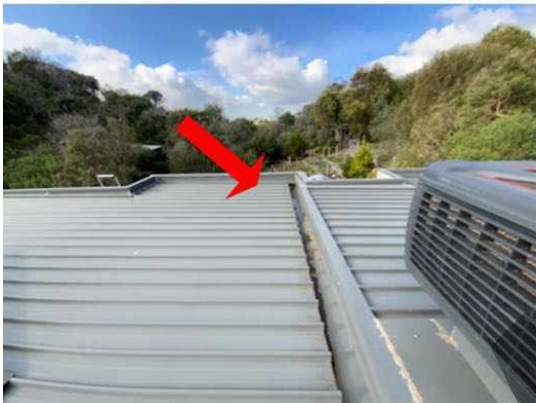
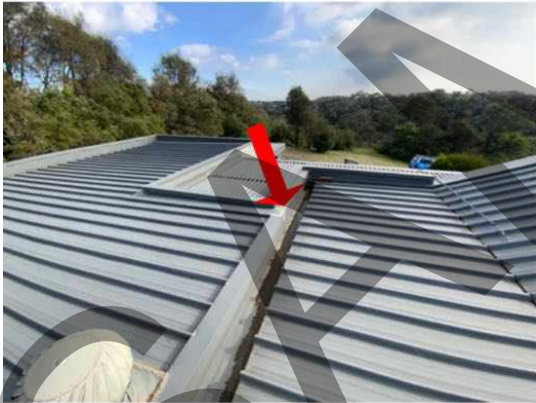
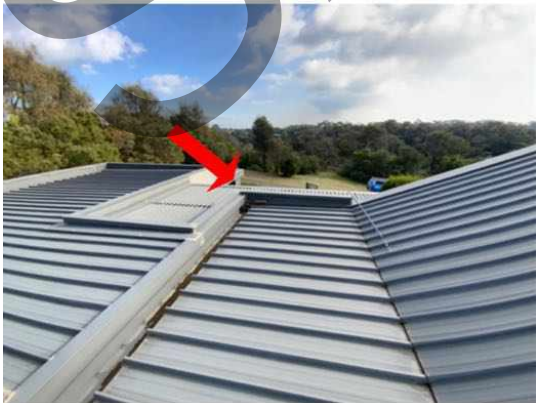
Defects 3.16

Building: Main Building
 Location: Roof Exterior
 Finding: Gutters - Water pooling
 Information: Water was found to be pooling in sections of the roof guttering. This is generally a secondary defect caused by blocked or partially blocked gutters. Such blockages and subsequent water pooling are likely to lead to rust and water damage to associated structures if left unattended.

Depending on the extent of the damage, building elements may require repair and/or replacement to ensure adequate roof drainage and function of exterior plumbing system. The removal of bricks that have been used to secure flashing should also be conducted. If roof sections are found to be loose they should be fixed directly to the adjoining structures.

A roofing plumber should be appointed as soon as possible to rectify this issue. It is highly advised that all gutters be maintained on a frequent basis to ensure the condition of roof plumbing.

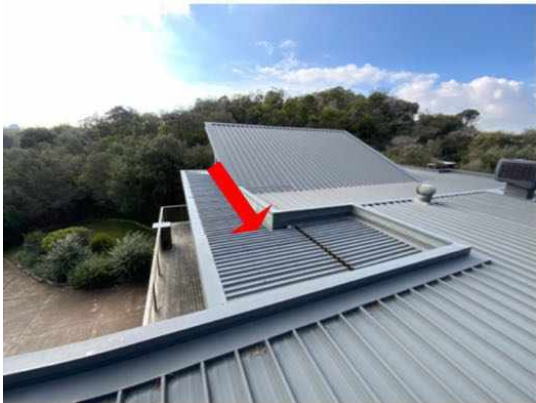
Defects 3.17

Building: Main Building
 Location: Roof Exterior
 Finding: Roof Fixings - Rusted
 Information: The roof fixings show areas of rust and corrosion. Rusted roof plumbing will generally develop holes and leaks that can affect other building elements with poor drainage of storm water. Repair and/or replacement of rusted roof fixings is required in order to reinstate the roof to a fully operational level.

A licensed plumber or specialist roof restoration company should be appointed to undertake these works. It is advised that such works be completed as soon as possible to prevent any further damage and deterioration.

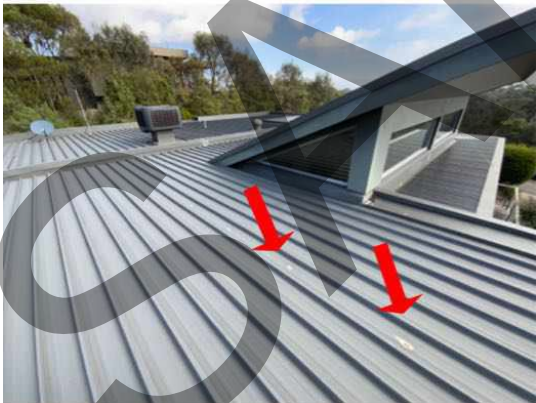
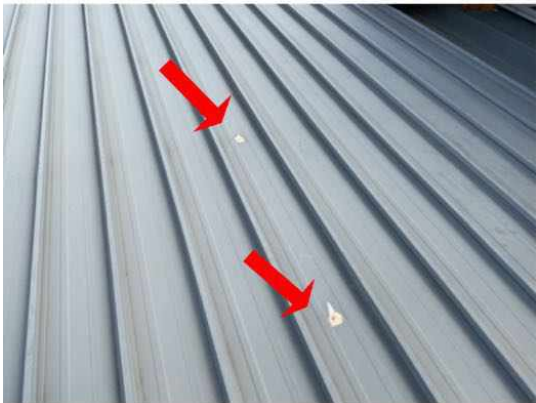
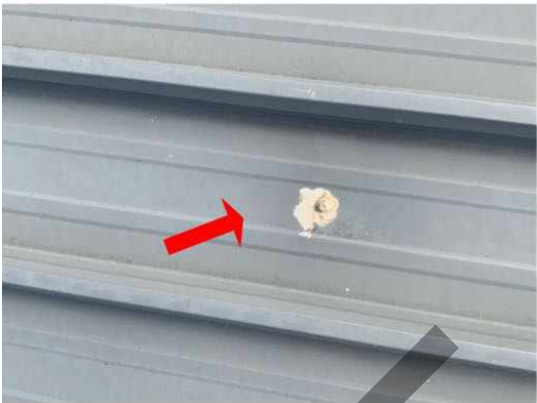
Defects 3.18

Building: Main Building
 Location: Roof Exterior
 Finding: Silicone Application - Excessive
 Information: The silicone repair work performed to the roof fixings appears to have been completed to an unsatisfactory standard. Excess silicone was evident in sections of the roof area providing a blemish on the appearance as well as detracting from the drainage of the area.

While weather-tight the excess silicone should be removed in order to increase drainage and to prevent accelerated deterioration of the adjoining materials. Replacement to sections of the roof sheeting may be required if excessive holes are found.

A roofing contractor may be appointed to perform these works at client discretion.

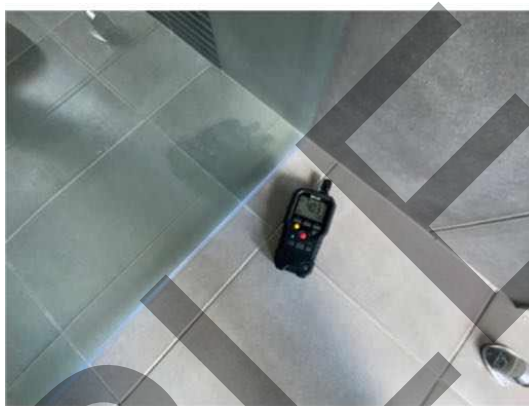
Noted Item

Building: Main Building
 Location: Bathroom > Lower-Ground Level
 Finding: Shower Alcove - Inspection
 Information: There was no visible evidence of water escape from the accessible areas around the bathroom shower alcove area in the ground floor area at the time of inspection. Plasterboard walls, ceilings, carpet, furniture, cabinetry or timber skirting adjoining the shower alcove showed no evidence of water staining or damage at the time of inspection.

Moisture readings taken at the time of inspection did not indicate any areas of elevated dampness to the external areas of the shower alcove and to the opposing walls of the property at the time of inspection. (See attached photos) If the Property has been vacant for a period of time, moisture levels or leaks may not be detectable at the time of the inspection because often only frequent use of water pipes (showers, taps etc) result in a leak being identifiable.

The client should be aware that areas such as shower alcoves should have regular inspections. Deteriorated grout and sealants should be immediately addressed to avoid water escape from the shower alcove from occurring. Even the smallest break in sealants or grout will allow water to escape into the adjoining structures.

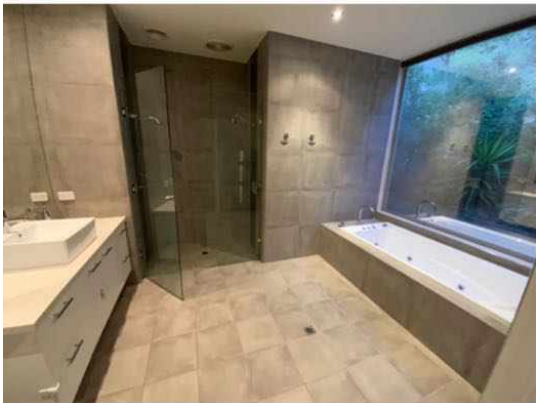
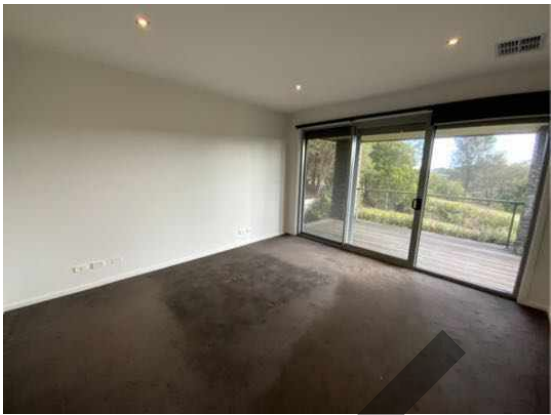
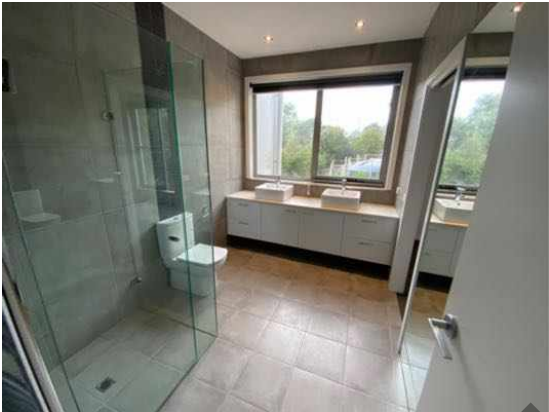
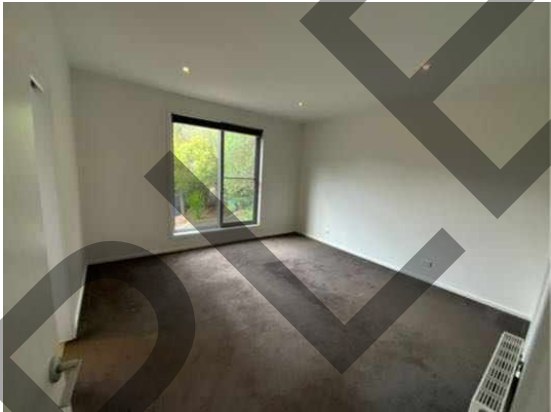
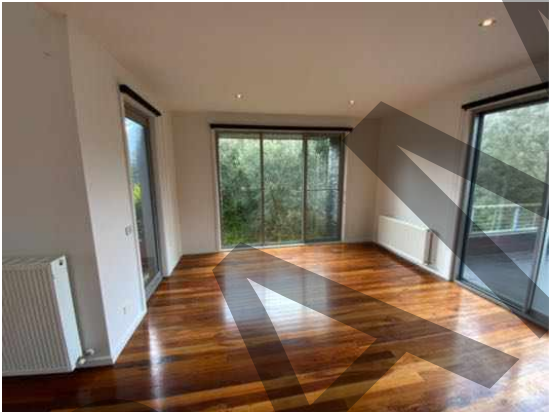
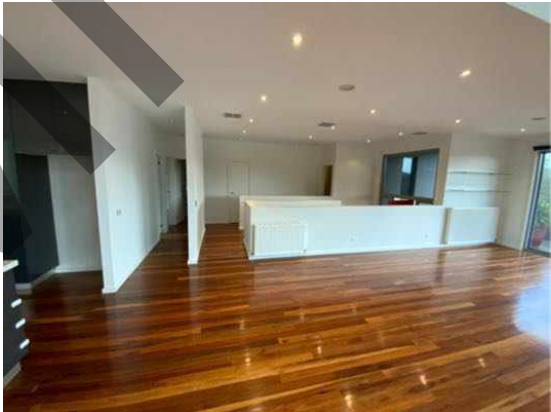
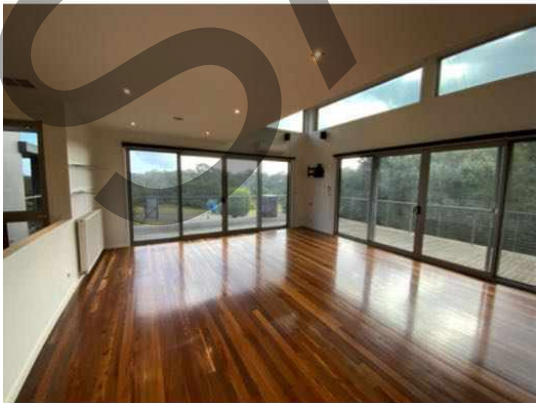
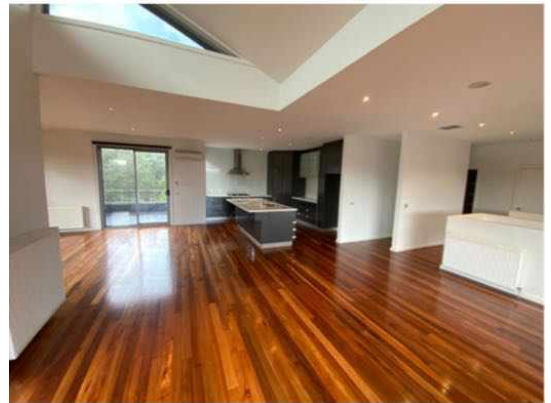
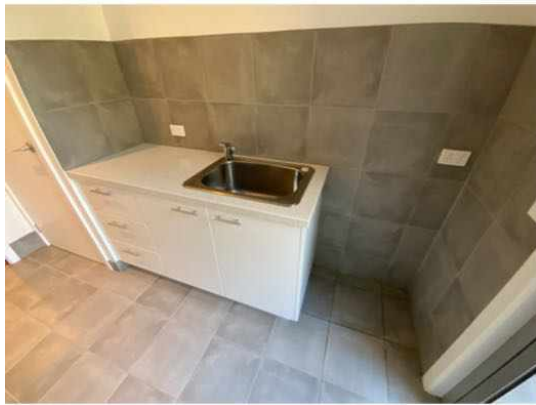
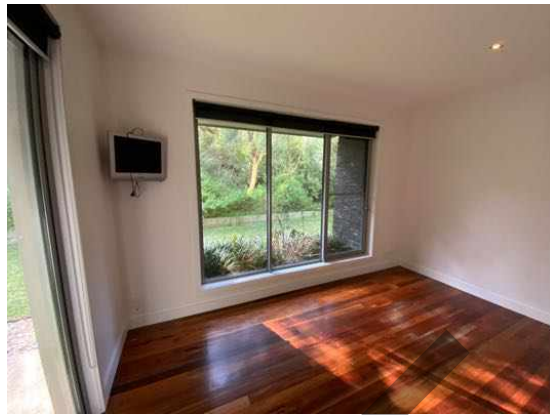
Noted Item

Building: Main Building
 Location: All Internal Areas
 Finding: Obstructions & Limitations - Internal Areas
 Information: These photographs are an indication of the obstructions and limitations which impeded full inspection of the internal areas at the time of inspection. The inspection of the internal areas was restricted due to facts including but not limited to:

- Built in Cabinetry
- Floor coverings
- Window coverings
- Locked doors or windows
- Wall and ceiling linings

The limitations described above, are not intended to be an exhaustive list and we endeavour to identify any limitations or restrictions specific to the property as soon as possible. A re-inspection of areas that are obstructed or limited should be conducted once the access has been provided.
