Building Inspection Report

Inspection Date: Sat, 10 Jul 2021

Property Address: SAMPLE REPORT - PRE PURCHASE

Company Name: Jim's Building Inspections

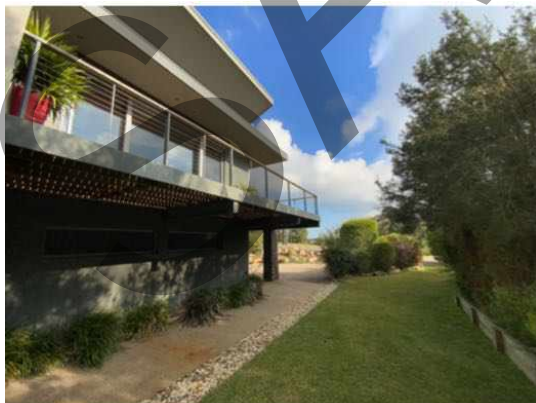
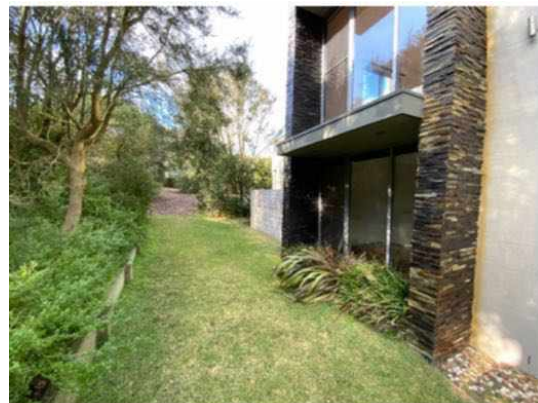
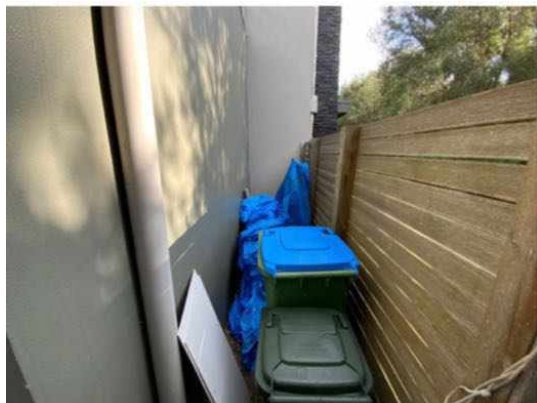
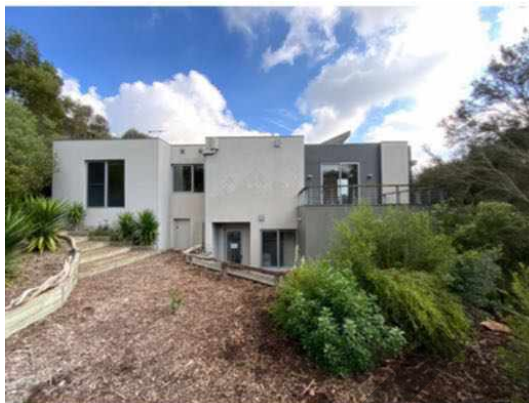
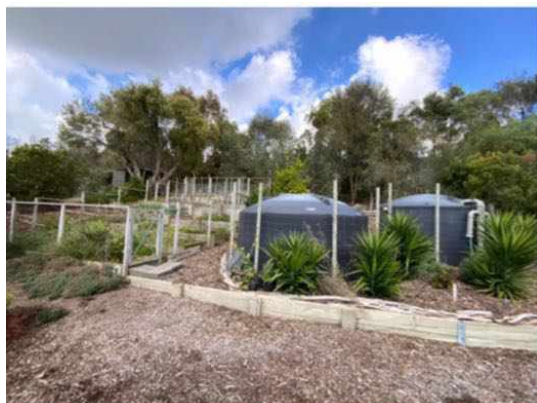
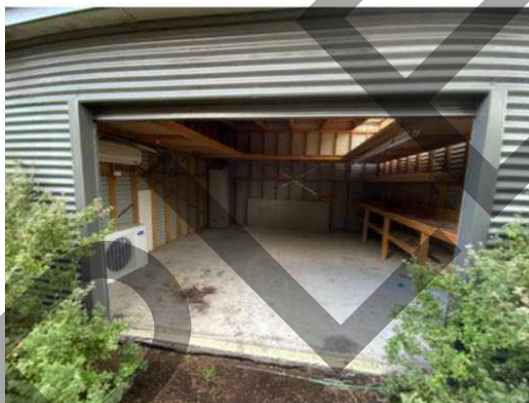
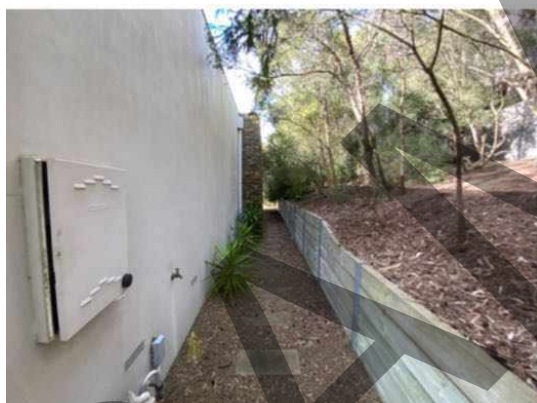
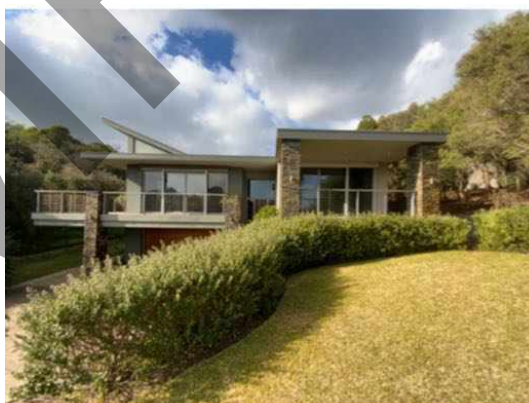
- Vegetation
- Stored Items
- Above safe working height

The limitations described above, are not intended to be an exhaustive list and we endeavour to identify any limitations or restrictions specific to the property as soon as possible. A re-inspection of areas that are obstructed or limited should be conducted once the access has been provided.

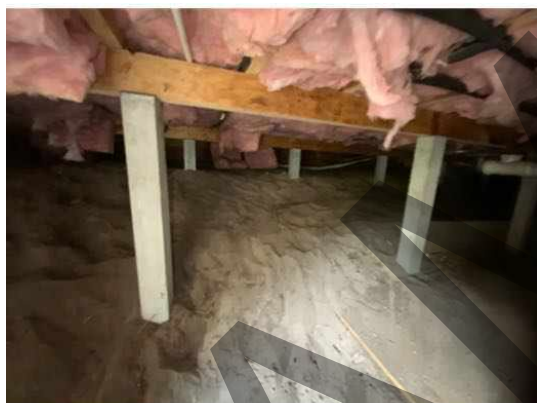
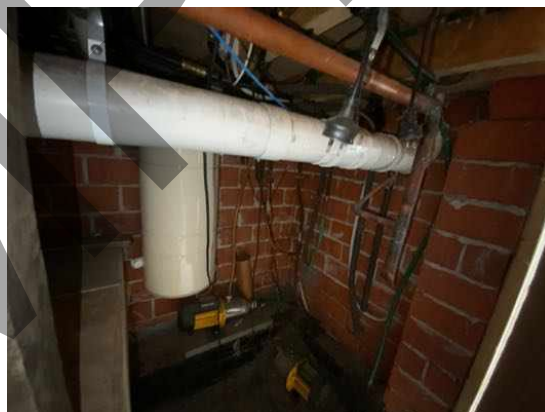
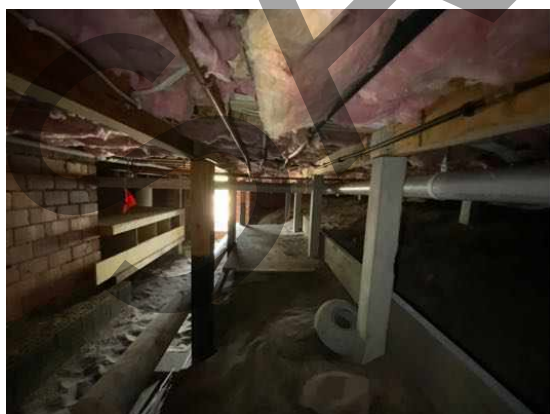
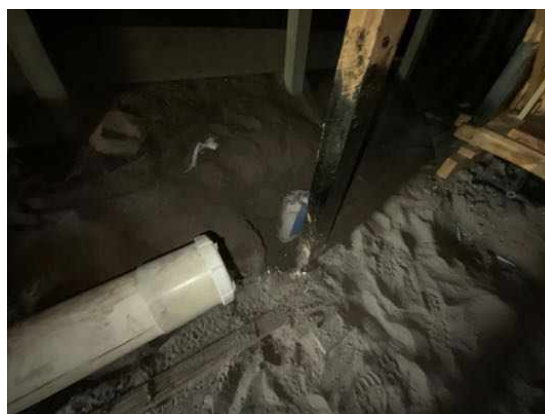
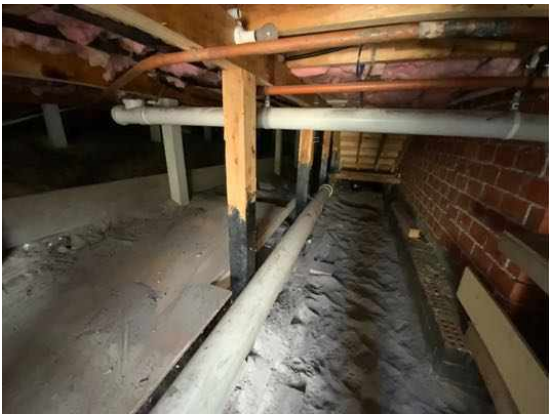
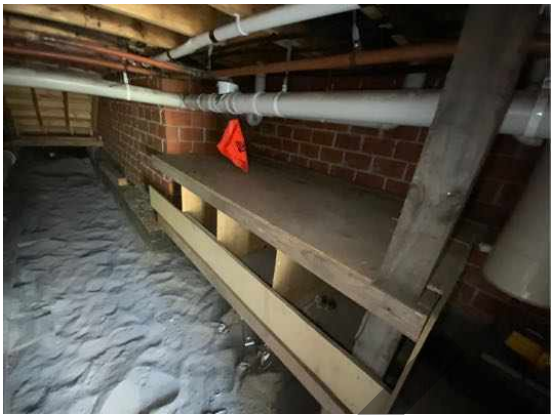
- Low clearance
- Insulation
- Poor lighting
- Air conditioning unit or ductwork
- Pipework

Were access is obstructed or limited there is always a HIGH risk of building defects or timber pest damage being present. Please contact a Licensed Termite / Pest Controller for further advice.

The client may consider conducting a further invasive inspection of subfloor areas were access is obstructed or limited. Please note that invasive inspections are outside the scope of this report. A registered Building Practitioner should be engaged to conduct any invasive inspections of the subfloor area.
